ENFIELD ARCHAEOLOGICAL SOCIETY ARCHIVE REPORT

**EXCAVATIONS AT ELSYNG PALACE, FORTY
HALL, ENFIELD, MAY - JULY 2018**

(SITE CODE FXQ18)

by
MARTIN J. DEARNE

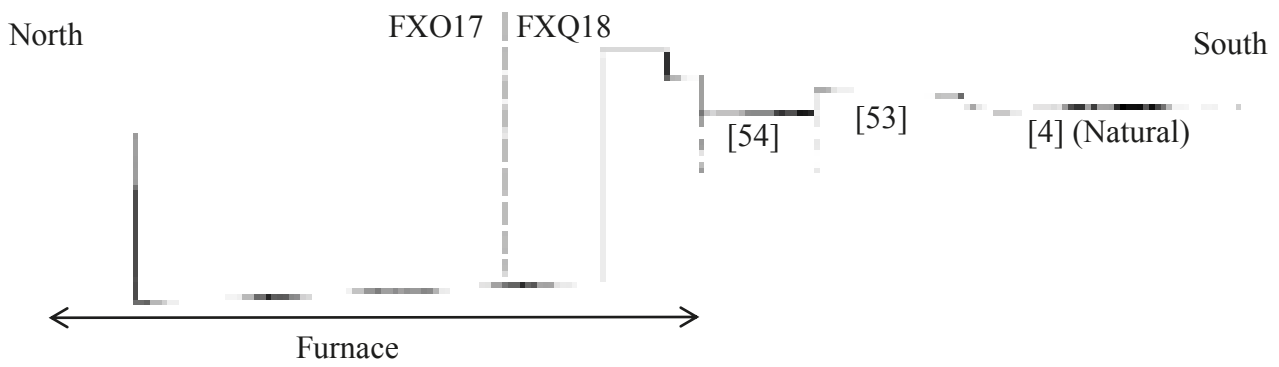
Section Across the Widest Point of the Furnace

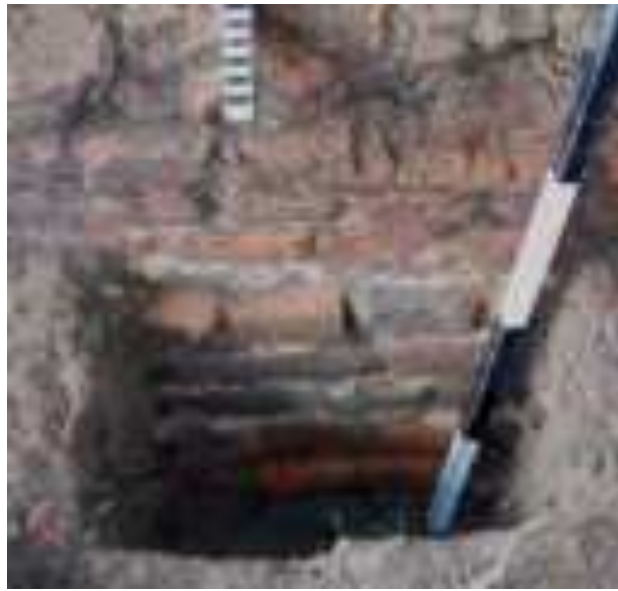
Pl. 1: South Face of Wall [8] (Photo MJD)

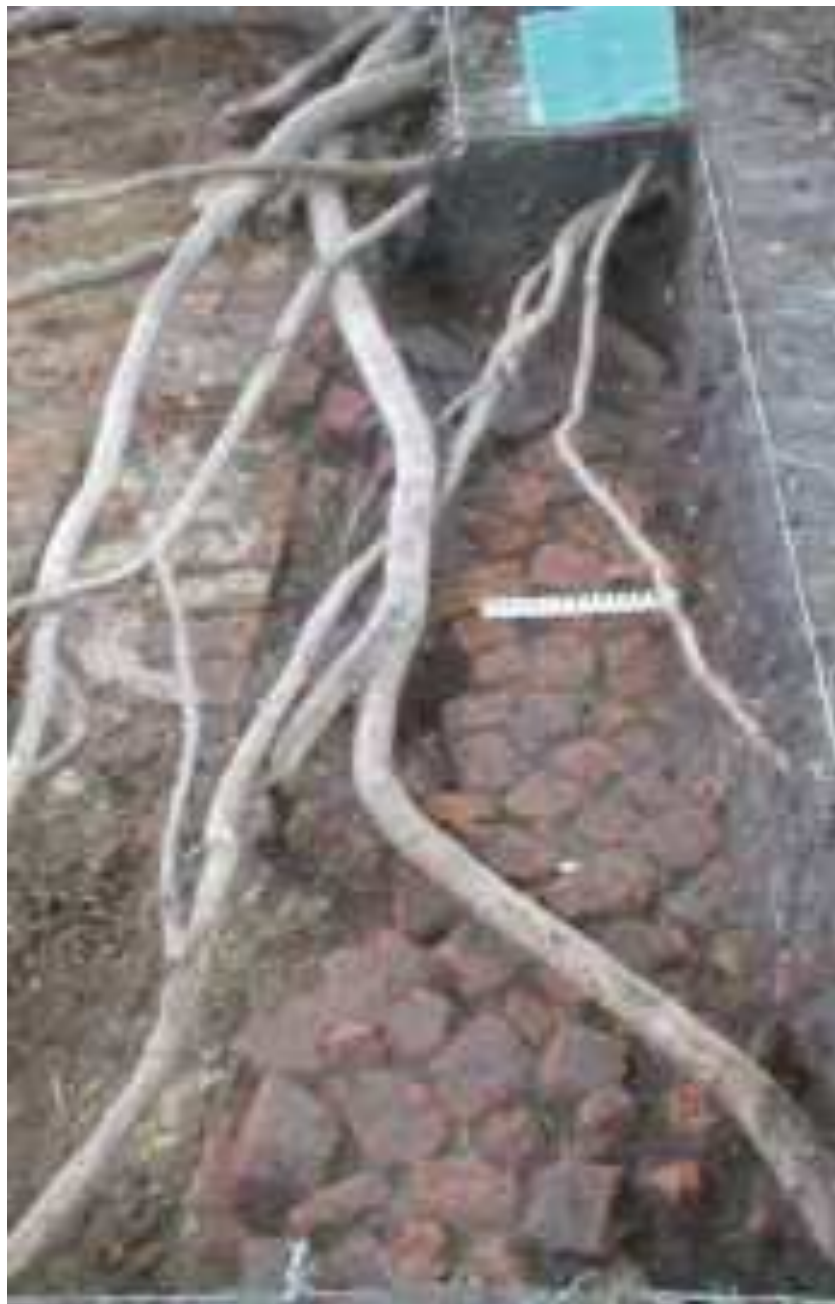
Pl. 2: Part Demolished Wall [8] and Phase 3c Floor [18], Looking East (Photo MJD)

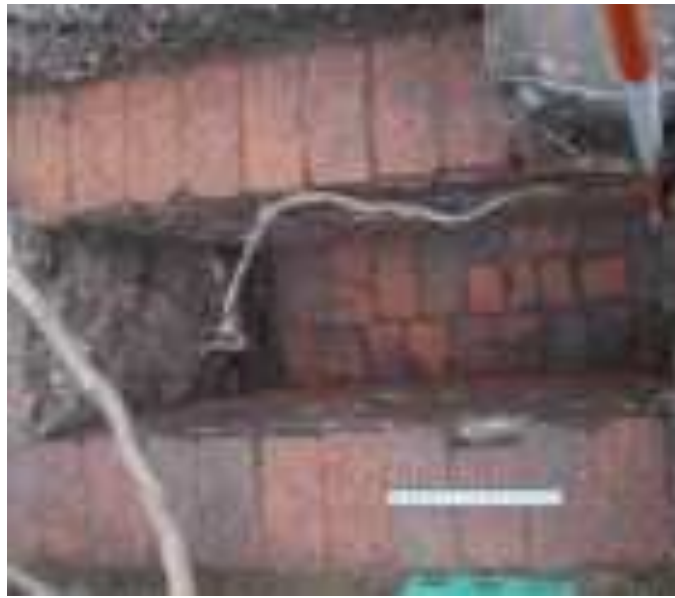
Pl. 3: Drain [15] (Photo MJD)

- By contrast in the northern part of the building relatively little brick rubble ([7]) lay on floor surfaces in Room 3 except where they had probably been damaged during demolition. However, [21], the fill of the major drain [15] at the northern edge of the building may have been of Phase 4. Although the exposure of this drain fill in 2017 (FXO17 [28]) had suggested that it was a silt, only in its upper horizons with demolition material in it (Dearne 2017c, 19), the present work fully cleared a larger section of it (and partly excavated an area of it where there had been Phase 3 modification) which allowed the full study of complete sections through the fill. Only moderately compacted, the fill was, as in 2017, a dark brown (10 YR 3/3) clayey silt, here with moderately frequent brick fragments (to 0.10 m, some retaining mortar) and peg tile fragments (to 0.10 m), some oyster shells and roundwood charcoal as well as rather more frequent and larger rounded pebbles (to 0.04 m) than in 2017. The presence of the brick fragments throughout the deposit to the base of the drain suggested that it was more likely a deposit connected to site demolition, or at least a mixture of drain silt and backfill, than just a silt relating to use of the drain. This fill also had an upper surface level with the top of the drain which might not be expected if it had simply been a silt and processing of bulk samples of it found that it contained 67% by weight of pebbles and 2.9% by weight of cbm fragments. The bulk sample processing also recovered a small amount of animal bone including from pig, rabbit, rat and mouse as well as egg shell fragments and four *teleostid* fish bones including one from the Common Carp (*Cyprinus carpio*), but it now seems most likely that the fill was at least largely deposited as part of the demolition process as probably emphasised by the presence of a fragment of a ragstone fireplace in it (see Appendix 3).

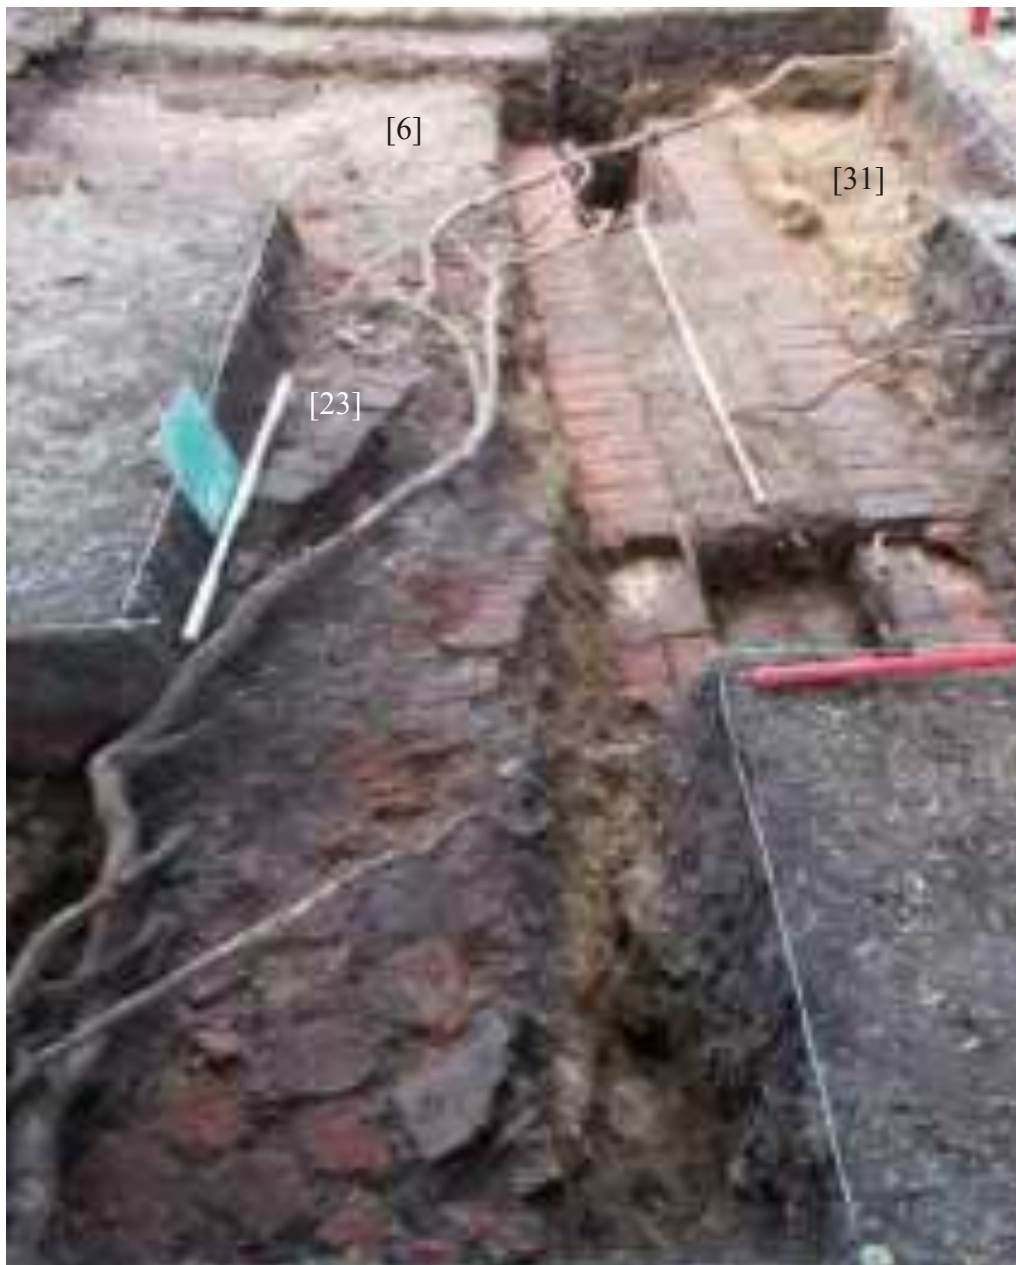
Pl. 4: Cut [31] (Top Right), Drain [15] with its Phase 3 Modification in the Foreground, to Left Floor [6] and (Foreground) Corner of Wall [5]/[23] Flanked by Surface [24], Looking West (Photo MJD)

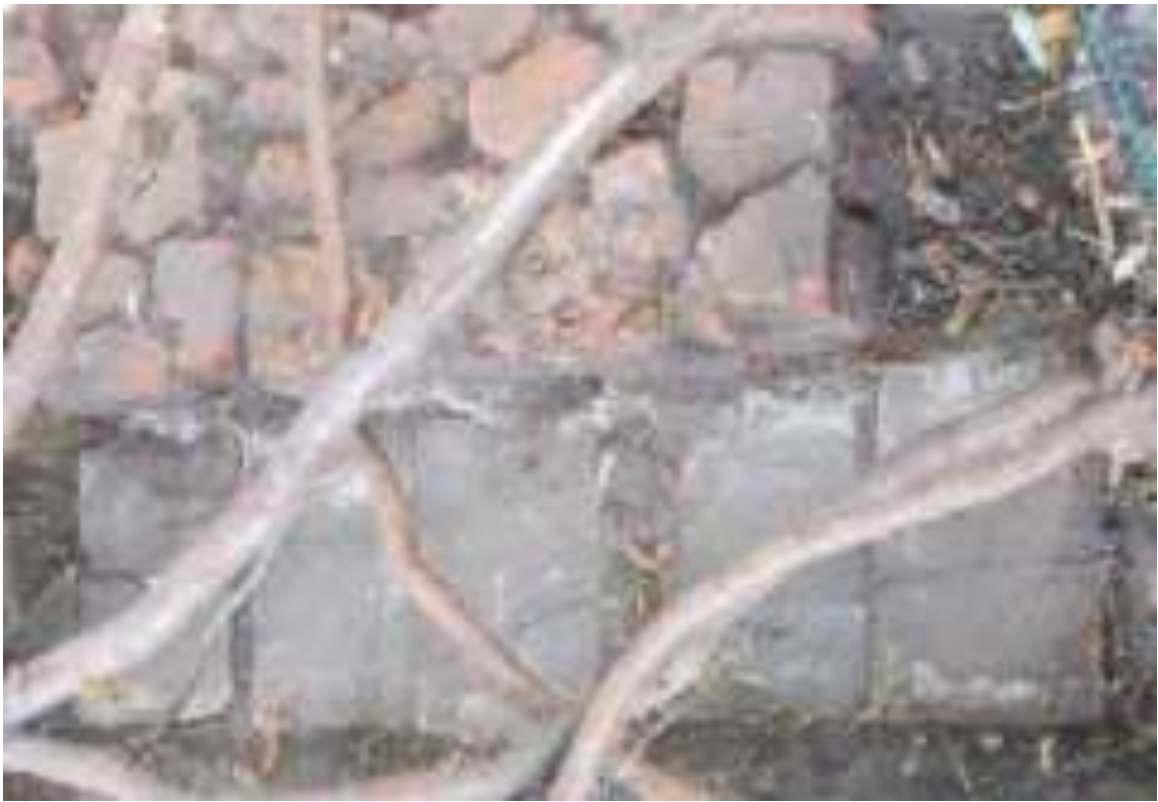
Pl. 5: Detail of Wall [46] Showing Whitewash/Mortar Outlining the Base Beam with Phase 3c Floor [55] to the East (Top) (Photo MJD)

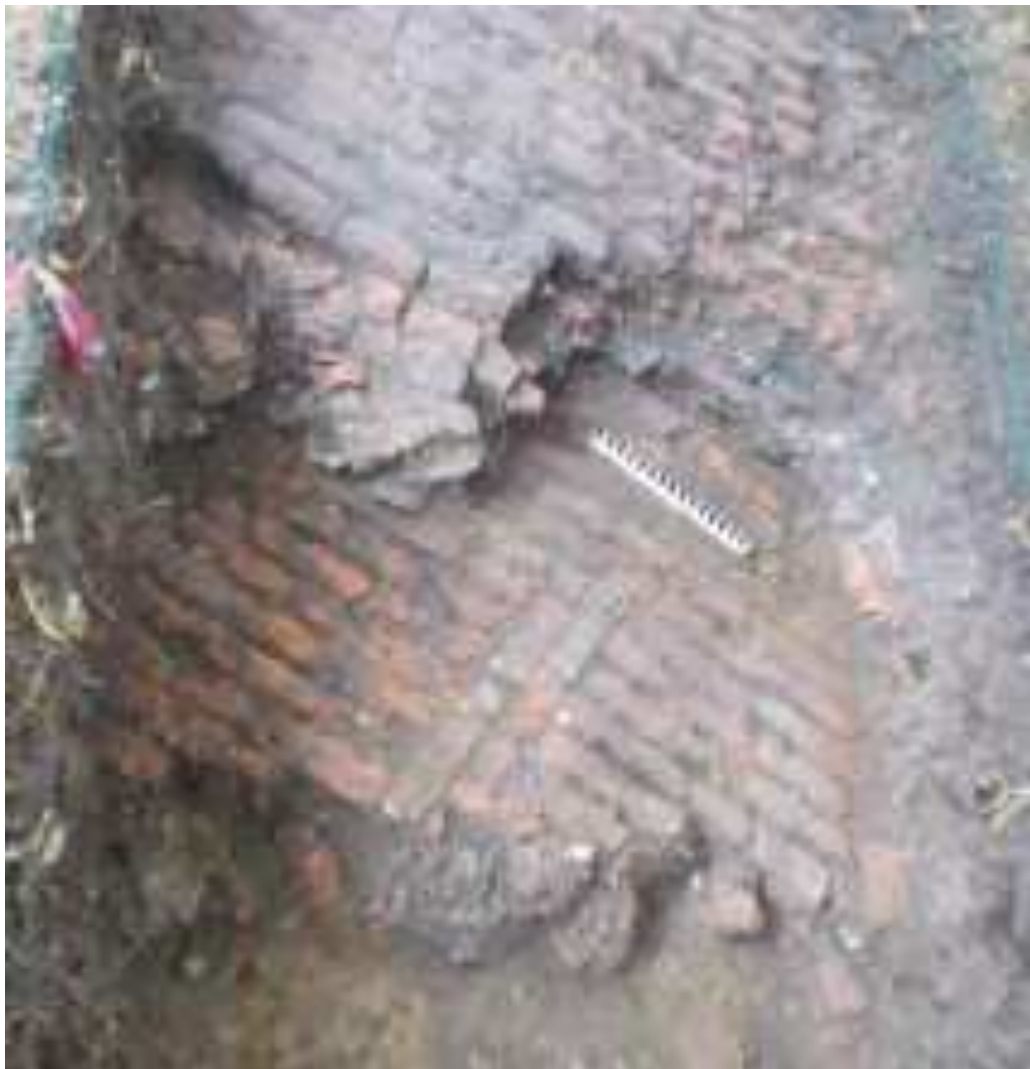
Pl. 6: Phase 2 Floor [40] Exposed Below Phase 3b Floor [32] by Cut [41], Looking West (Photo MJD)

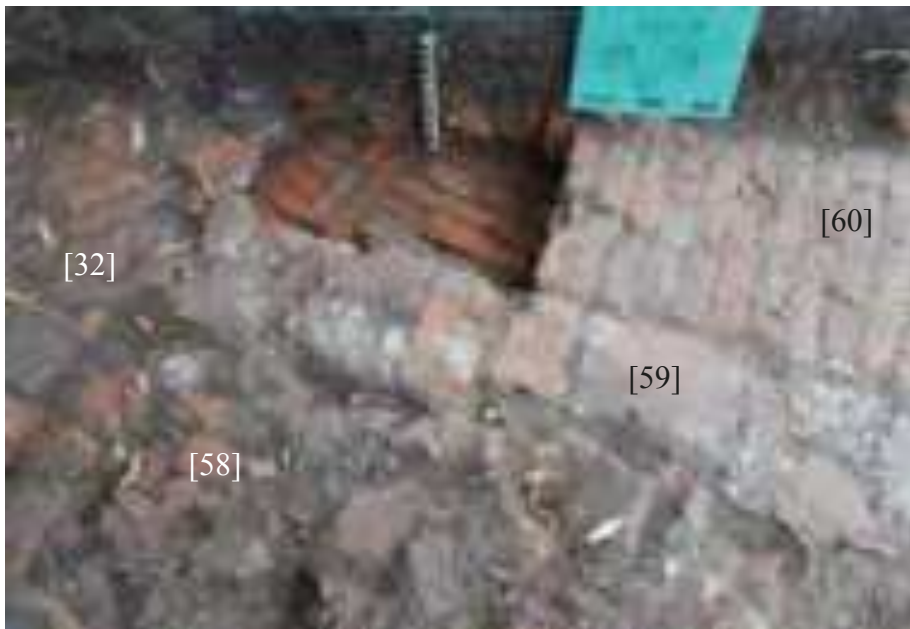
Pl. 7: Phase 2 Floor [70] Exposed by the ?Removal of a Later ?Wall at the North End of Phase 3b Floor [60] Beside Wall [59], Looking East (Photo MJD)

- Unremoved later floors prevent certainty, but Room 4 seems to have been divided from Room 6 by only a brick threshold (part of [32]) in Phase 3b (Pl. 7) and so may always have been open on the north. Excavation within this room in 2018 was limited and only served to confirm earlier findings that its very worn rammed pebble and chalk lump floor [57] (= FXO17 [12]) – only a remnant of which survived beside the threshold – lay on a rubble and brick dust bedding [58] (= FXO17 [13]) which was not fully removed in this instance (Pl. 7). This room in fact now seems to have been (or at some point to have been partitioned into) two irregularly shaped rooms, the northern, Room 4, from 3.20 to around 3.90 m east west and either 4.00 – 4.60 m or 4.60 – 5.35 m north south depending on which of two walls ([81] and [82]) formed the presumed division between it and Room 8 to its south. Neither wall can be certainly phased and the presence of a large and partly collapsed tree made excavation in the south of Room 4 and in Room 8 impossible. However, that the east wall of Room 4 ([59] = FXO17 [2]) is known from work in 2017 to have been a Phase 3 (indeed, it is now evident Phase 3b) rebuild makes it most likely that the room was divided sometime later in the building's history so walls [81] and [82] are discussed under Phase 3.

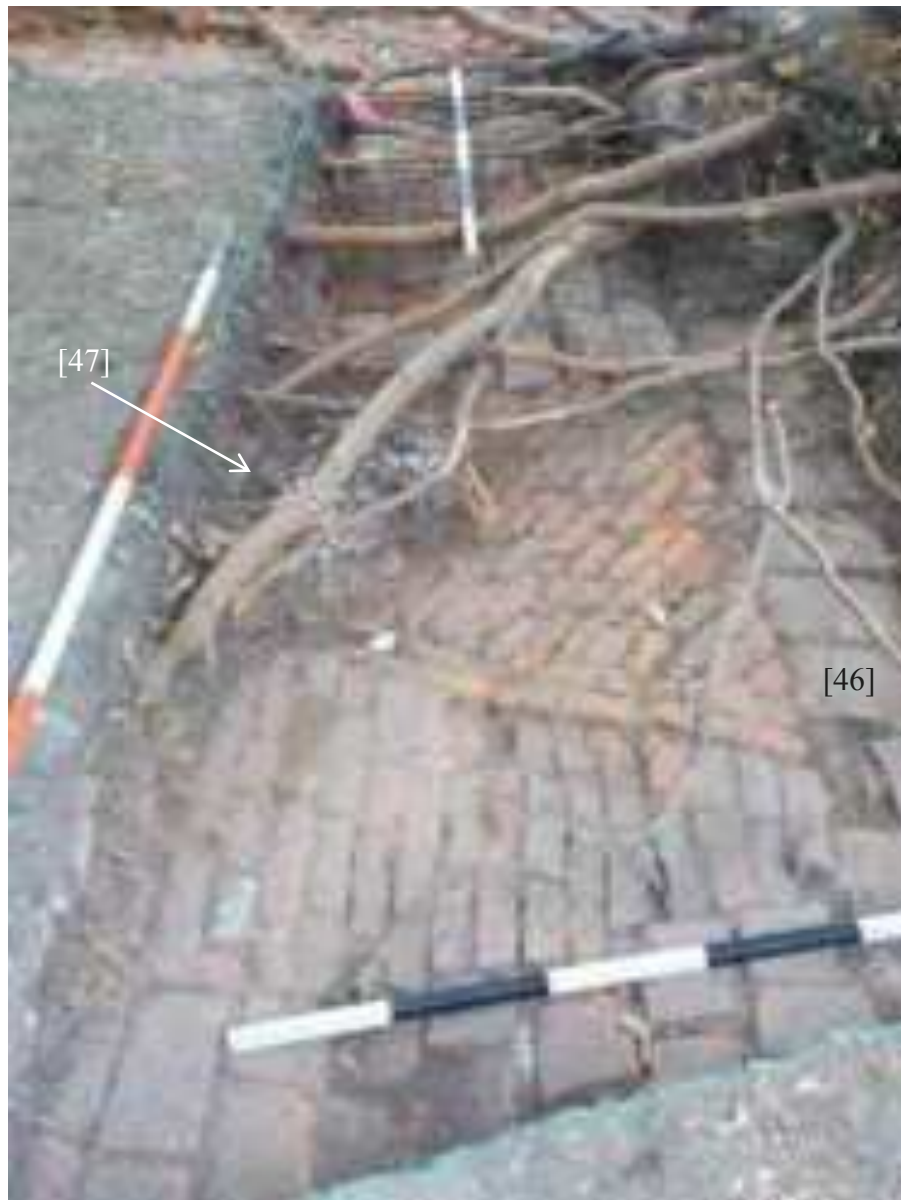
Pl. 8: Phase 3a Floor [56] Beside Wall [46] with a Block of Phase 3d Floor [47] Left *in situ*, Looking South (Photo MJD)

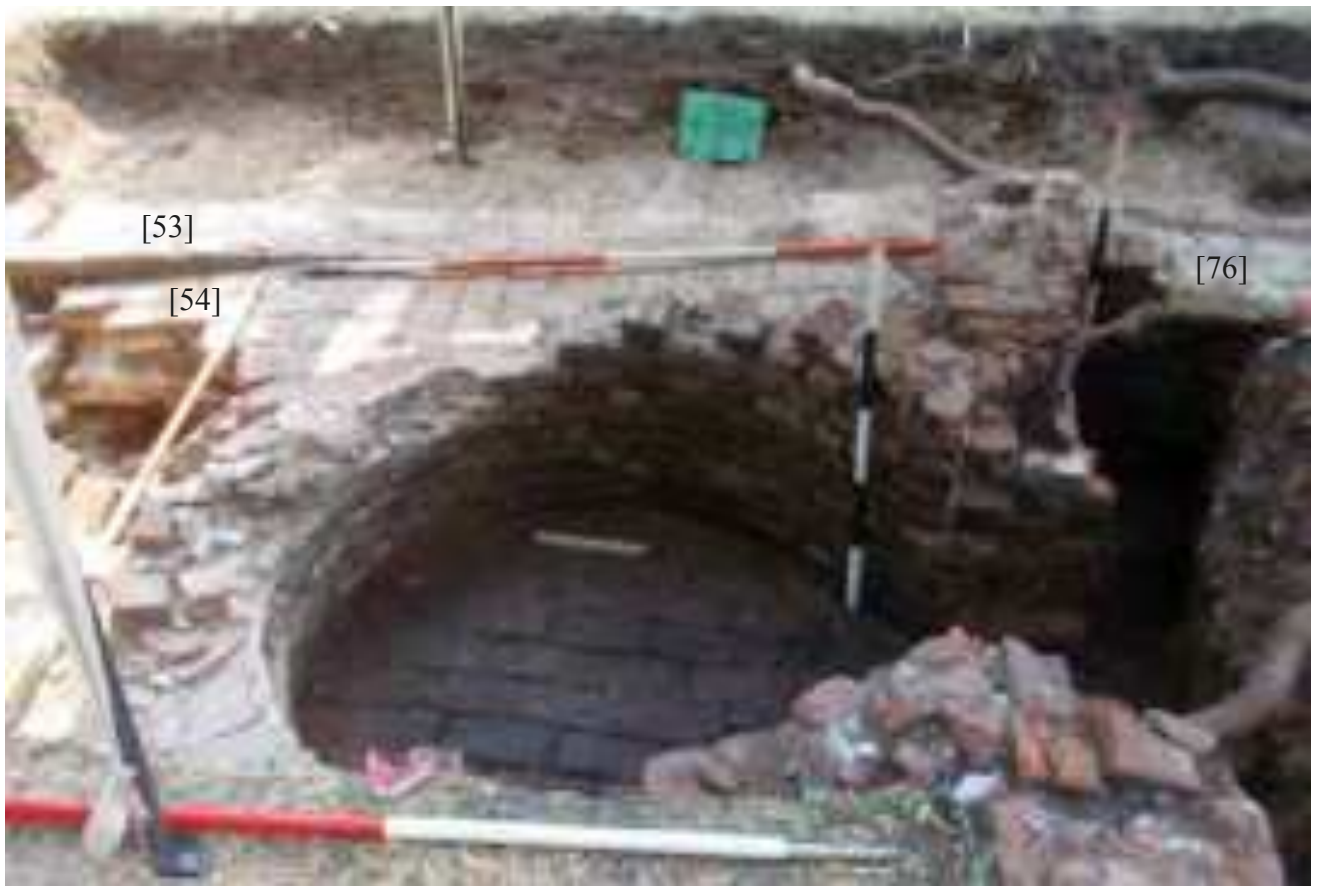
Pl. 9: Furnace [52] with Butressing Wall [54] Between it and the Facade Wall [53], Looking South (Photo MJD)

- The northern cheek of the furnace, [43]/[83], was more substantial than the southern (probably partly because it was not engaged in a wall such as [54]) and may have been integral with foundations intended to carry other structures associated with the functioning of the furnace. The southern end of the structure ([83]), forming the actual furnace cheek which in this case didn't quite align with the inner face of the main chamber, was badly disrupted, but was 0.34 m wide and survived to c. 0.62 m high, built of eight courses of whole and probably part bricks. It was bonded with relatively soft brownish yellow (10 YR 6/6) mortar, distinct from the very hard white mortar which the rest of this cheek (and [51]) used and the void in its west face was in this instance 0.14 x 0.22 x over 0.12 m long (tree root activity prevented its full clearance). Further north the cheek was continued for 0.44 m by the beginning of [43] (a curved joint in the upper part of the cheek between the two again perhaps hinting that [83] was a repair/modification). This first section of [43] comprised two skins of brickwork (c. 0.50 m wide), but it then expanded to the east to a width of 0.72 m (three skins) as it ran a further 0.50 m north, incorporating the most easterly part which was recorded in 2017 (as FXO17 [54]),⁵ itself probably resting on the undemolished foundations of the 'earlier' furnace to the north (FXO17 [60]).

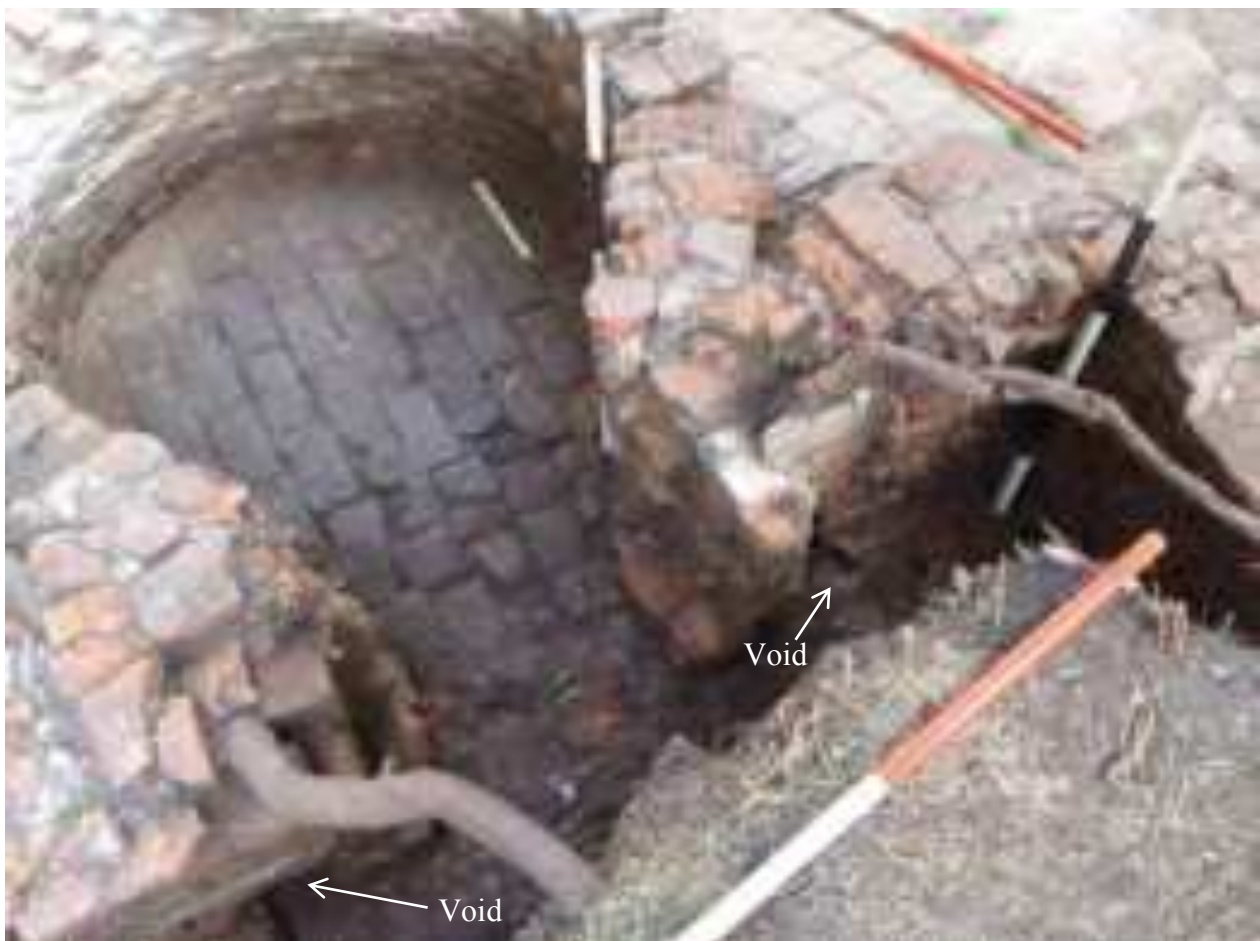
Pl. 10: Furnace [52] Looking East, Showing Damaged and Root Disrupted Cheeks [43]/[83] (to Left) and [51]/[84] (Photo John Pinchbeck)

in 2017. Thus, parts of the damage to the cheeks of the furnace was clearly being worsened by the ingress of major tree roots (Pls 10 and 13), much of the western part of Room 5 was if not disrupted then in danger of being disrupted by major tree roots (Pl. 11) and at one point wall [62] had been cracked apart and moved by tree root heave. Again, even just deturfing showed that the westernmost exposure of wall [76] has probably already been irretrievably disrupted. As emphasised by the findings in Trench 8 (and FXO17 Trench 1) especially, repeated tree throw/planting has already rendered some areas archaeologically useless and no new tree planting or sapling seeding should be allowed in this area under any circumstances. Indeed, it is to be greatly regretted that tree planting was allowed in ENC05 Pit 23 (tree 0833) some years ago and the immature tree now occupying this position may well in due course pose a threat to the survival of features such as the Room 5 furnace.

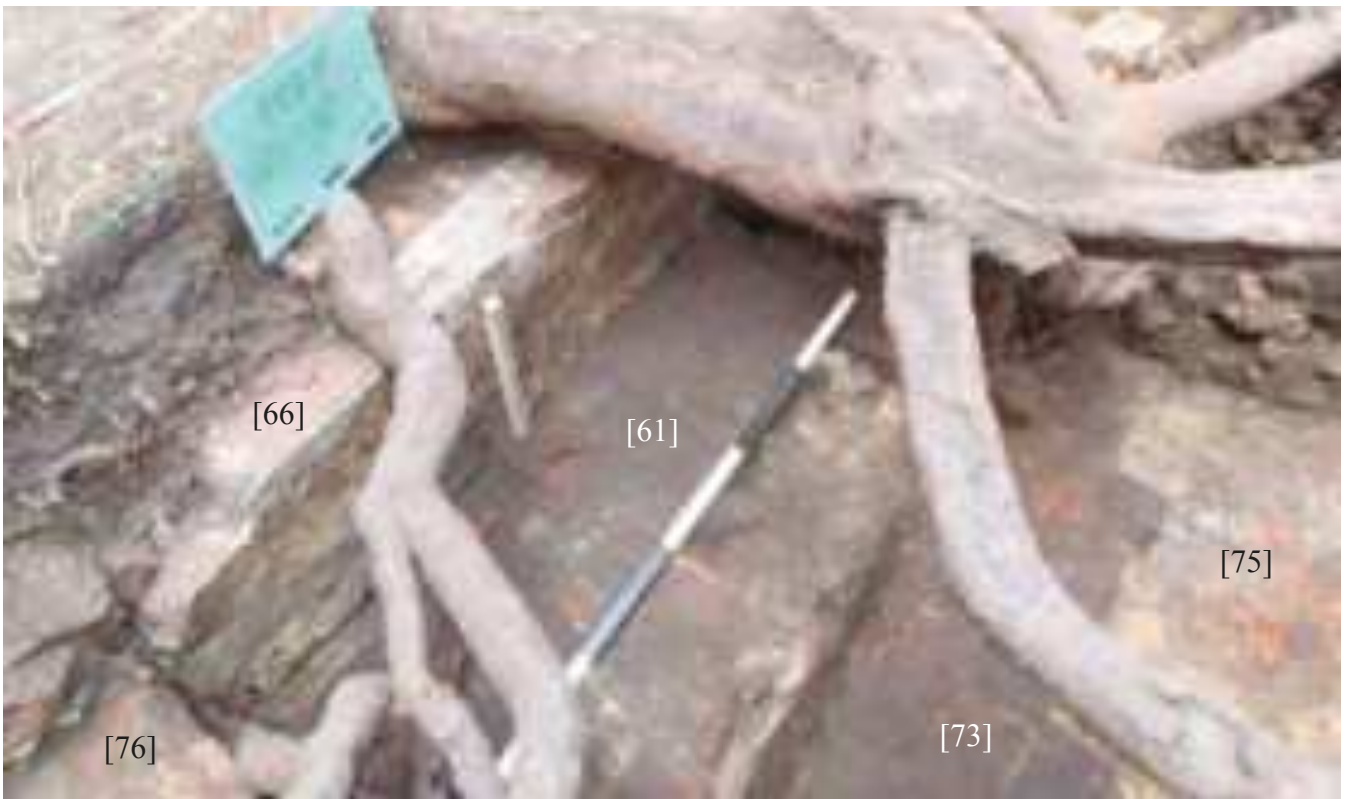
Pl. 11: The Room 5 'Cupboard', Looking North (Photo John Pinchbeck)

- At the north end of the ‘cupboard’ was a c. 0.90 x 0.58 m block of brickwork, [42], which survived to 0.43 m high, but the base of the 0.09 m thick mortared rubble foundations for it lay 0.16 m above the level of floor [73] (at least in the small east face exposure available). Above the foundations it survived to five courses of probably rather irregular English bond brickwork bonded with a hard, very pale brown (10 YR 8/4) mortar, though the top surviving surface showed the use of the very hard white mortar used for the ‘cupboard’. As well as forming the north side of this ‘cupboard’, the construction had an integral 0.47 m wide north west running arm forming wall [81] which was built on/into the natural, perhaps in a construction trench backfilled with [87], a redeposited brickearth with rare brick fragments seen only in the north section of the trench. [81] survived to four courses of whole and part bricks, perhaps laid as stretcher bonded faces to a rubble core and probably using the 10 YR 8/4 mortar.

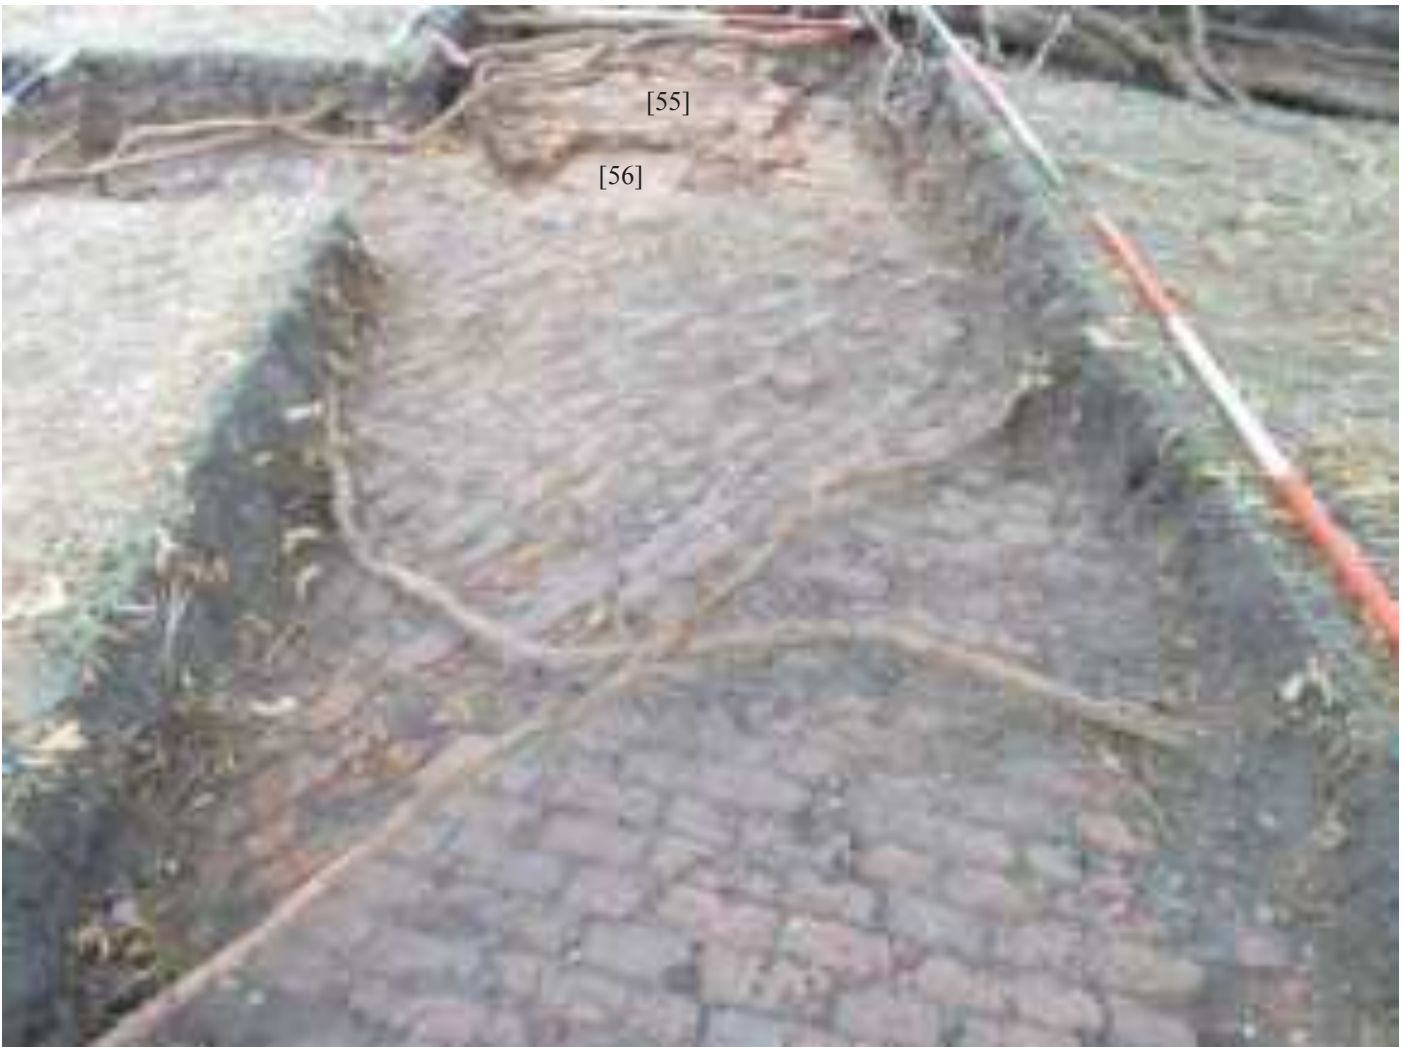
Pl. 12: Phase 3b Floor [32] Looking West with Phase 3a Floor [56] and Phase 3c Floor [55] at Top (Photo MJD)

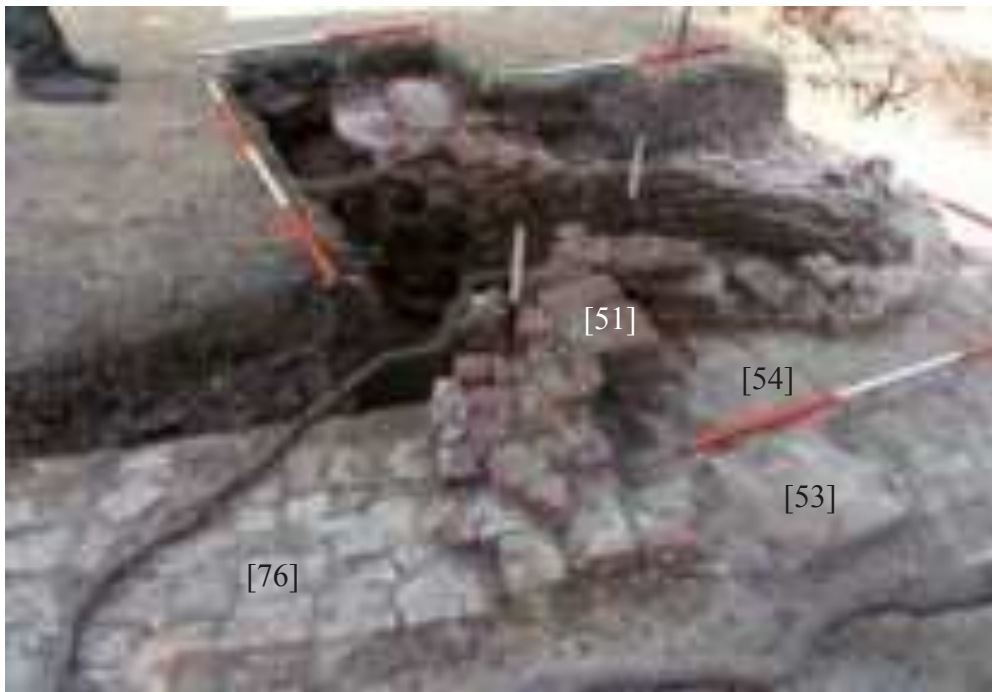
Pl. 13: The Junction of Walls [76] and [53]/[54] and Furnace Cheek [51], Looking North (Photo MJD)

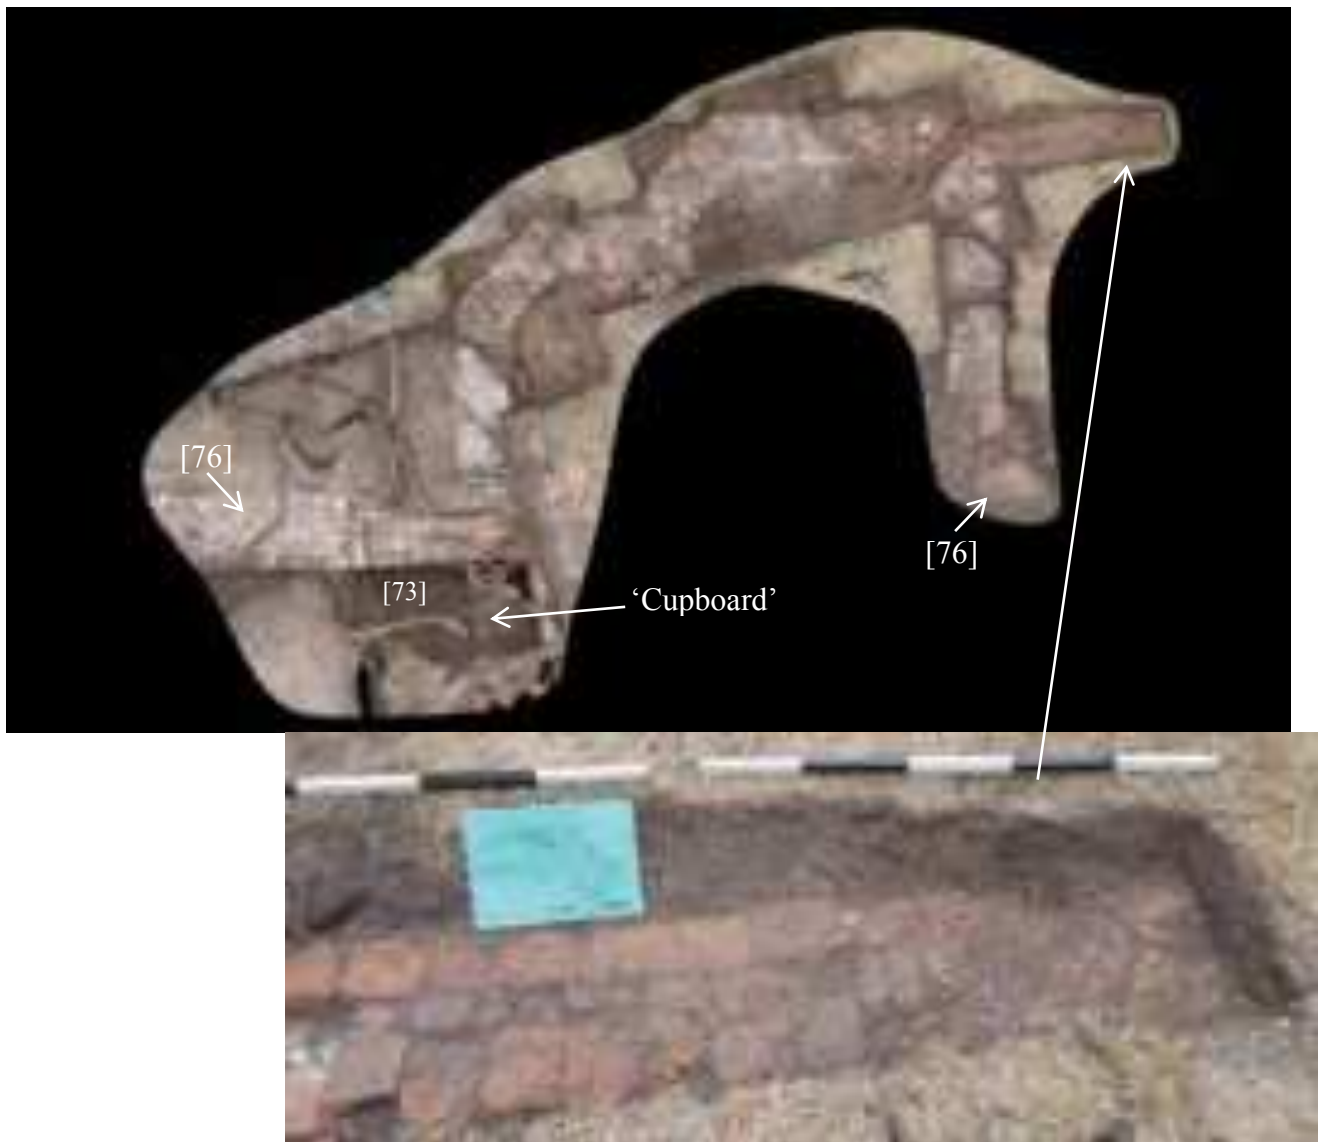
Pl. 14: Multiangular Tower [62]/[84] (Vertical Photo Mosaic by John Pinchbeck) with Detail of Damage to Wall [84] Looking South (Photo MJD)
