ENFIELD ARCHAEOLOGICAL SOCIETY ARCHIVE REPORT

**A SECTION ACROSS THE SOUTHERN
PERIMETER OF ELSYNG PALACE, FORTY
HALL, ENFIELD, JULY 2014**

(SITE CODE FXI14)

MARTIN J. DEARNE

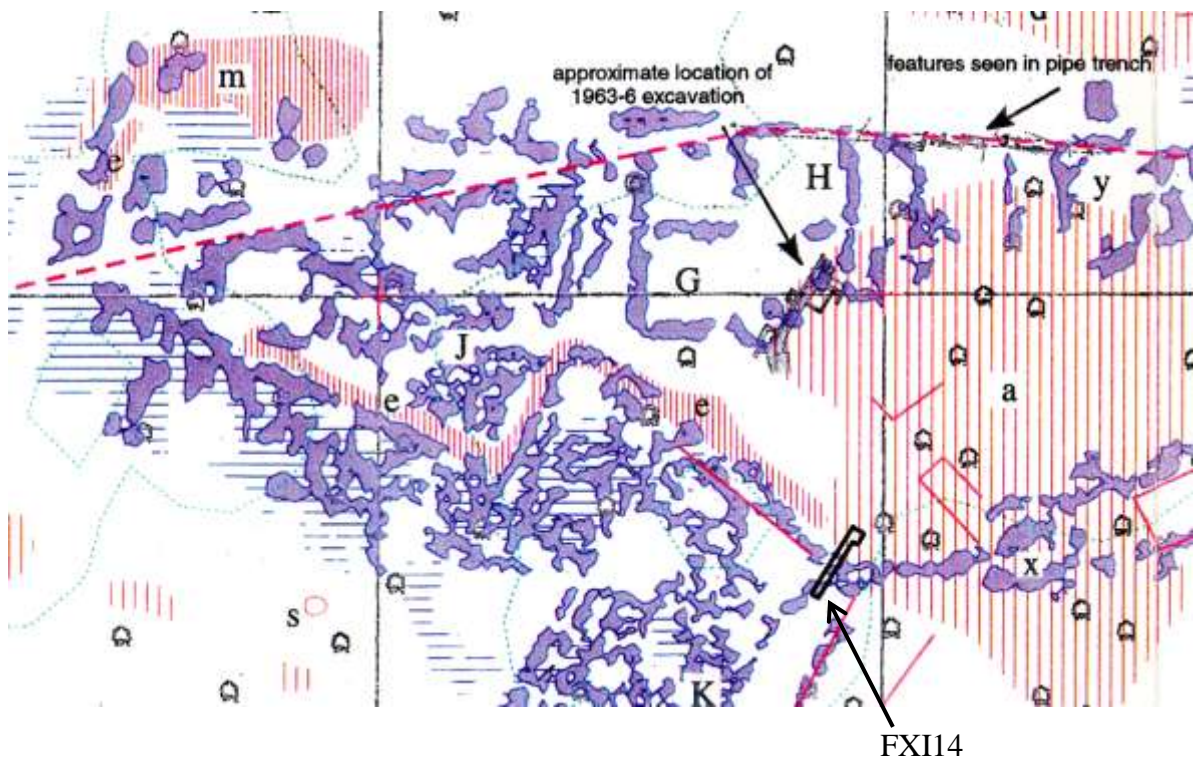
Fig. 1: Bartlett (1989) Plan 7 in Relation to FXI14 Trench (1:1500)
 (N.B. the 1963 – 6 Excavations are Misplaced by Bartlett; see Fig. 6 for the Correct Location)

- A resistivity survey in 1968 near the main 1960s excavations is known only from a slide of its results (Dearne op cit), but magnetometry and resistivity surveys were carried out in 1997 and 1998 and ground penetrating radar and topographical survey in 2000 (Horsley 1997; Bartlett 1989; and see Phillpotts 2002, passim and especially Fig. 28). However, the problems subsequently identified with the magnetometry and resistivity surveys and noted above should be emphasised.

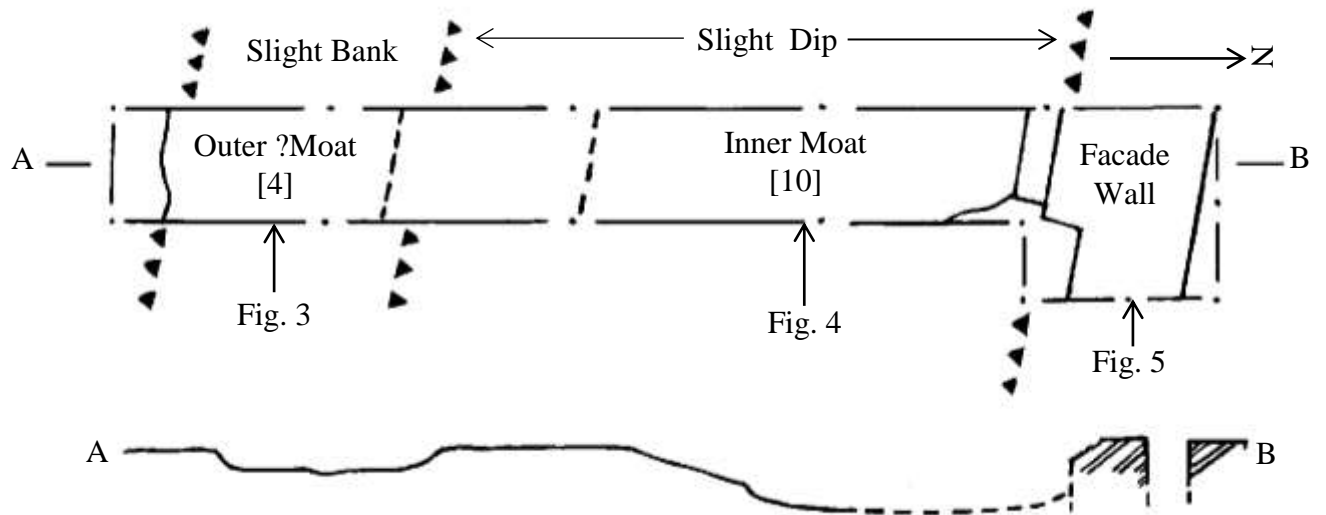
Fig. 2: FXI14 Main Features, Surface Topography and Overall Section (1:100)

- This second dump filling moat [4] formed a low linear mound along its line, preserved in the modern topography (Fig. 2), and otherwise only extended a short distance south of the moat and possibly just north of it (?overlying [6] (below)). It clearly derived from the main phase of demolition and may well suggest that space for dumping rubble was now at a premium and or that it was expected that the earlier fill of [4] would settle more than it did.

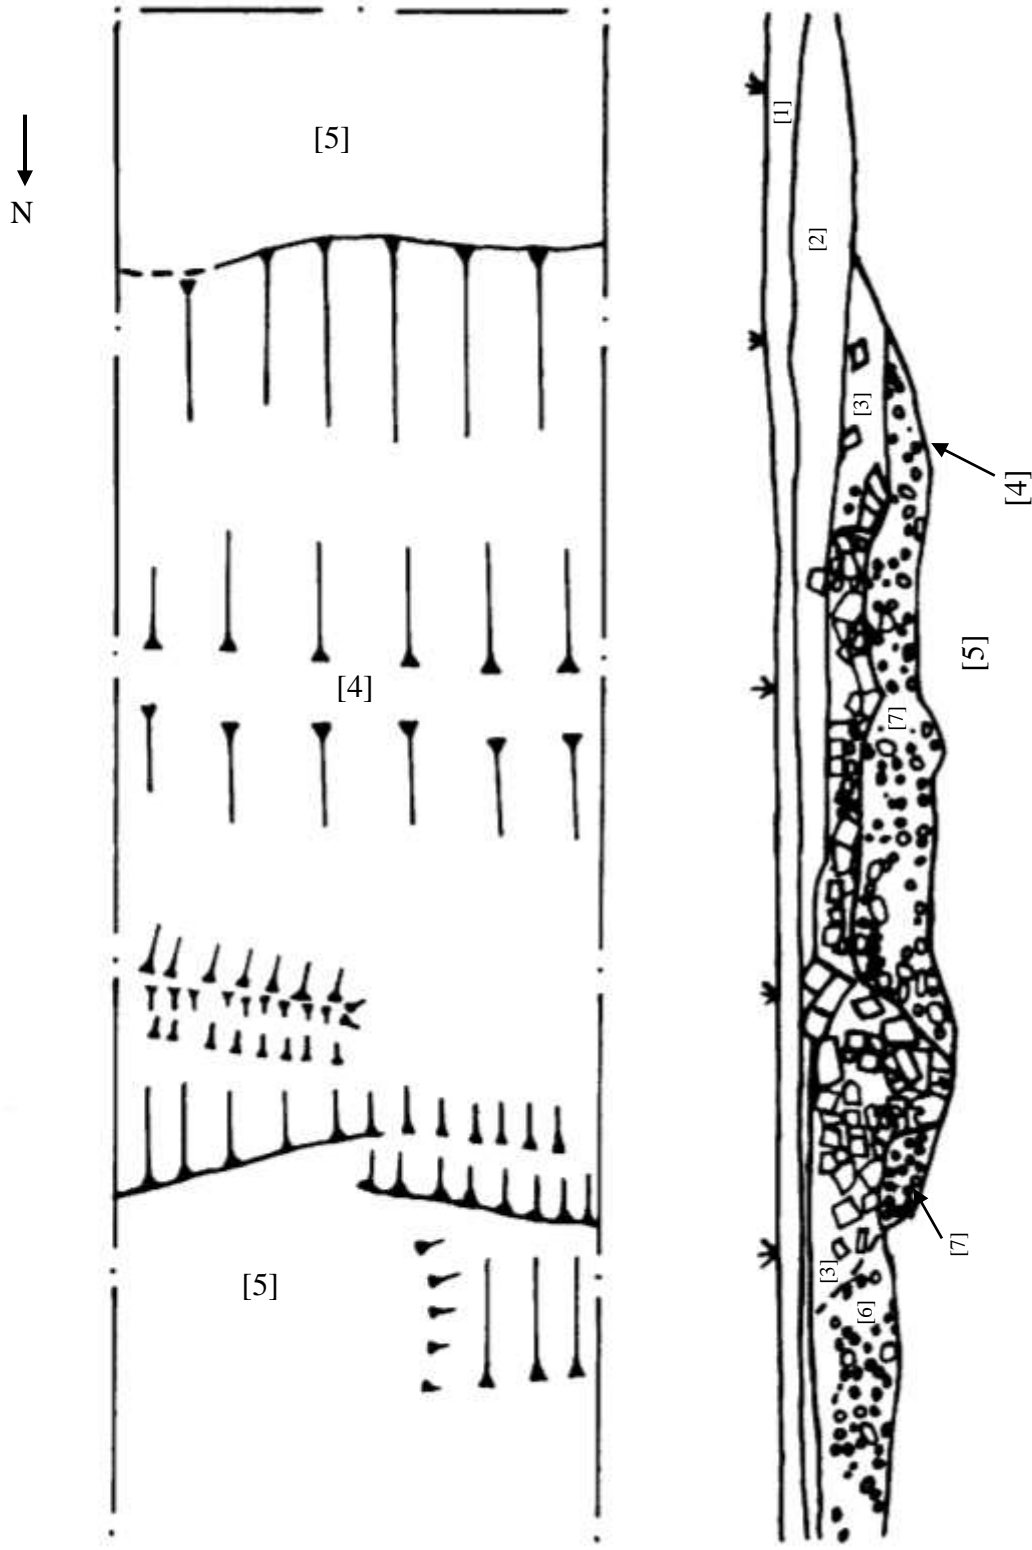
Fig. 3: Outer ?Moat [4] (1:20)

- [4] comprised a c. 3.00 m wide, fairly shallow (up to 0.22 m deep) channel with ill defined and 'rough' sloping north side (so that its exact orientation could not be established), basically flat but undulating base and sloping south side (Pl. 1). It was relatively hard to define as much of its basal fill ([7]) had a matrix identical to the natural and it is possible that its rather undulating sides in plan may have in part been artifacts of excavation. However, it appeared to have either been cut rather carelessly or to have been damaged (?during backfilling). There was no detectable primary silt within it which may suggest that it was either dry or more likely held standing not flowing water and, presuming that it ran for some distance, it is provisionally interpreted as an outer ornamental moat.

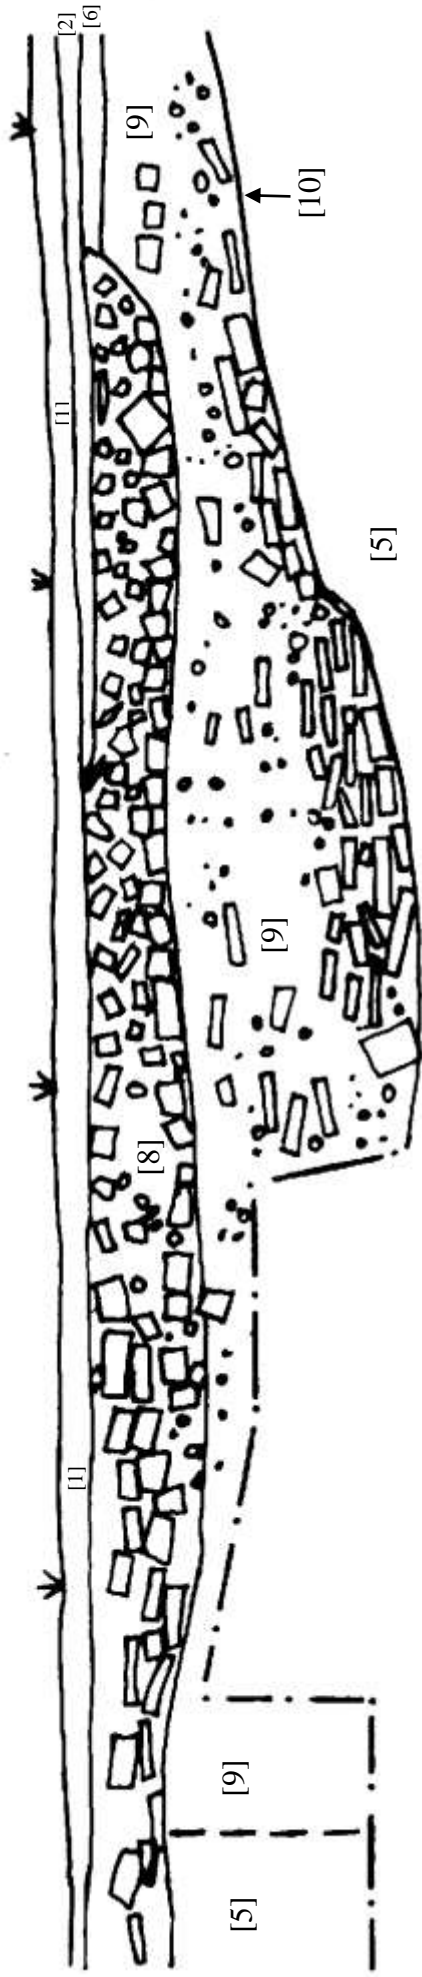
Fig. 4: Inner Moat [10] (1:20)

- Approximately 2.60 m further north, [10] was a much more substantial feature only the southern half of which could be excavated to its probable base in the eastern half of the trench and the upper part of the northern end of which could only be examined in a small area again on the east side of the trench. Again its basal fill, [9], was in large part redeposited natural which made defining the cut very problematic and some features such as an apparent step in the cut on the south could have been illusory while no precise cut line could be traced for its south edge. However, it was clearly up to 6.00 m in width and probably a maximum of 0.80 m in depth. On the south it appeared to have an approximately 1.50 m long, c. 45° slope interrupted by a step, curving in plan but untraceable in section, and an isolated bowl shaped deepening (not shown on figures), before another small step led to a more U-shaped central profile. On the north differentiation from natural was particularly problematic and findings here should be taken as provisional, but it appeared that the cut curved away to the south and east from a projecting section of the palace facade wall ([11] below) which it ran up to. So it may have had an edge in plan that ran over 1.60 m south of and presumably parallel to the main part of the palace wall (decreasing the cut's width to 4.40 m or less) but curved right up to it where the wall projected out. Certainly a mortar fillet east of the projection (below) means that it cannot have run right up to the main part of the facade wall here. There can be little doubt, whatever the precise details of its form, that the cut represented a more major inner still water ornamental moat fronting the palace facade and again the absence of any detected primary silt and geophysical evidence for its continuation over some distance (below) appear to be consistent with this.

- The main and basal fill of the larger moat, [10], was [9], a fairly compacted strong brown (7.5 YR 5/6) very clayey silt (brickearth) usually indistinguishable from natural except for the presence of from rare to dense brick and tile fragments. It seemed very likely that its deposition had begun early in the demolition process as the centre of the moat had c. 0.24 m (comprising five to seven dense horizontal ‘layers’) of part peg tiles (to 0.17 m) and some large brick fragments on its base, suggesting especially roof demolition (Pl. 3). However, above this the rest of the deposit, up to 0.64 m thick in all, comprised sterile brickearth with only rare rounded pebbles to 0.03 m and oyster shells and in some areas moderately frequent cbm smears/chips and fragments to 0.03 m, but also with dispersed ‘pockets’ of multiple tile fragments (to 0.21 m) and especially fragments of and part bricks. The brick and especially tile was, however, more consistently present for at least 1.00 m south of [11] (the demolished ‘buttress’ of which it covered), and here there were also moderately frequent lumps (to 0.05 m) of mortar matching that of wall [11] and in [13] and an over 0.20 x 0.10 lump of rounded 0.035 m pebbles, chalk and limestone fragments bonded with it. [9] produced only a few chips of Frechen Bartmann Ware (FREC; imported c. AD 1550 – 1700) and a lead pistol ball (Appendix 3). Whether the dumped natural largely forming it came from e.g. excavations to remove foundations elsewhere on the palace site or not it seems that the moat was as much being infilled as used as a convenient repository for demolition material.

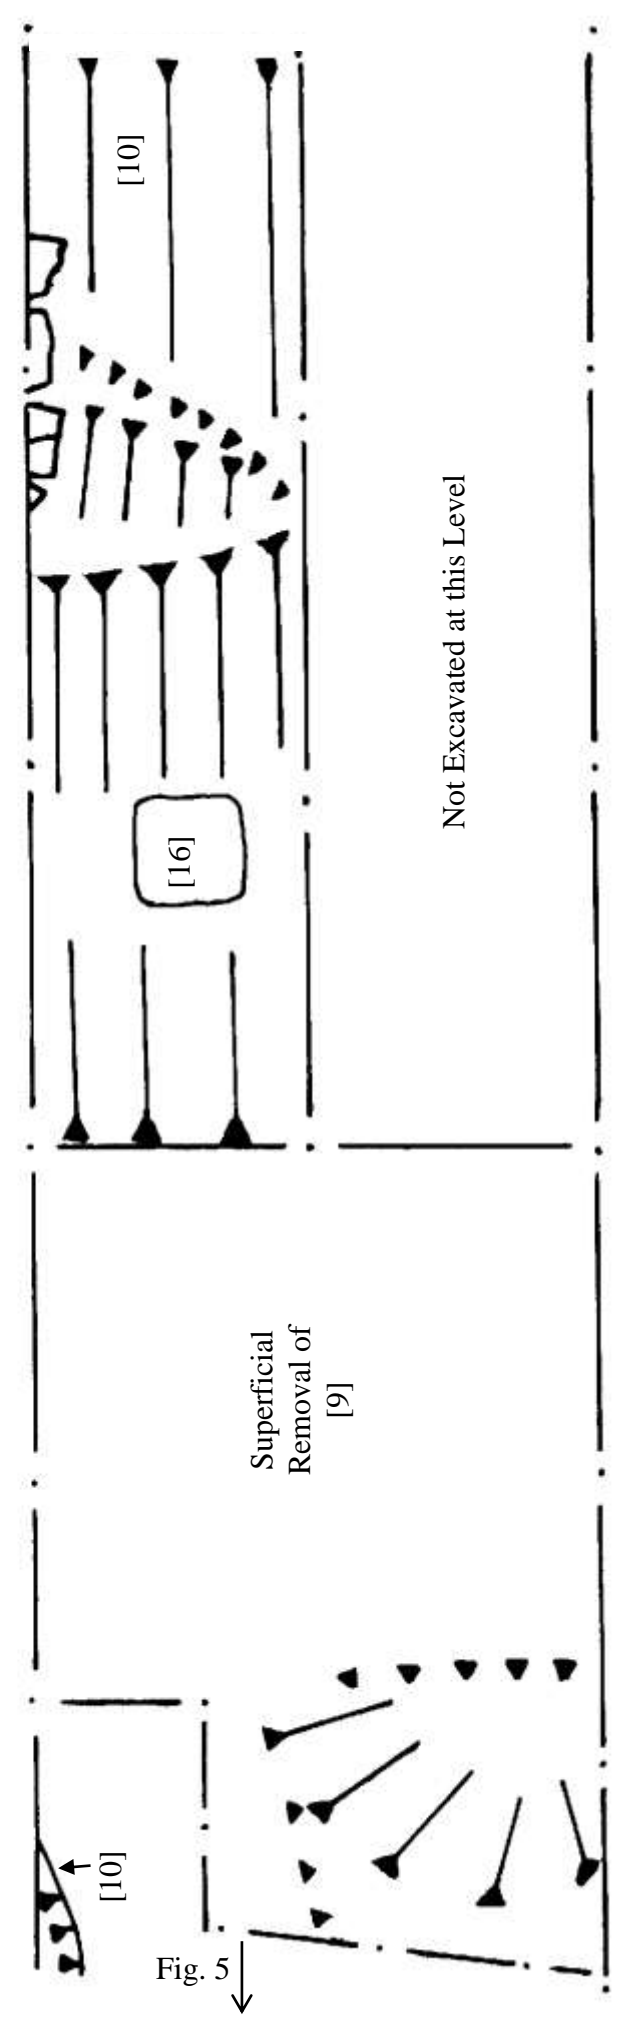
Fig. 5: Facade Wall, ?Buttress and North End of Inner Moat (1:20)

- The palace facade itself was represented by an extremely large wall with a southerly projection to accommodate a rectangular void, very likely a garderobe chute, in its thickness (Pl. 2). This probable garderobe chute, [17], was c. 0.98 x c. 0.56 m, straight sided and excavated to a depth of 0.63 m, but clearly continued deeper. Different areas of the wall were contexted separately ([11], [12] and [14]), but there was no evidence for more than one phase of construction so the whole structure is henceforth referred to as [11].

- Overall [11] was 1.30 m wide, broadening to 1.80 m (2.14 m including a thickening along part of its south face) where the 1.60 m long southerly projection to accommodate the probable garderobe chute occurred. The wall had been demolished to different levels at different points, with much of the thickening of the projecting section especially roughly and inconsistently demolished so that it survived to (various) far lower levels than the rest of the wall except at its east end. Moreover mortar obscured some details, tree root penetration had destabilised some areas and some sections flanking the probable garderobe chute had partially collapsed inwards. Without disassembling the wall its construction details were therefore not completely clear, but it appeared mainly, judging particularly from the sides of the probable garderobe chute, to have had a header lain core at least to its foundations with, at least in the usually uppermost surviving one or two courses, an outer skin of

- South of the probable garderobe chute part of the face of the wall had been thickened by 0.34 m for a length of at least 1.30 m, probably to form a projecting buttress (and at a depth greater than the limit of excavation presumably including an outlet into moat [10]). This ?buttress survived to over five courses (0.45 m). Here too, for the full width of the projection, header lain bricks also continued to the level that elsewhere stretchers began, with only the east side of the projection having a stretcher corner flanked by queen closers just above a small offset. Thus, the projecting section of the wall could have been continued up in header bond possibly for decorative contrast. Also, immediately above the highest surviving (chamfer edged) stretcher course on the north one, and at one point perhaps a fragment of a second, course(s) of probably originally complete peg tiles had been lain and were matched by one fragment above the highest surviving brick course of the part of the wall south of the probable garderobe chute. This suggests a bonding course of tiles, perhaps restricted to the section of the wall holding the chute, which could have been partly decorative in intent, though it is far from impossible that they marked the position of an actual garderobe as an adjacent floor (below) also seemed to end in line with the chute. To the east of the projection in the wall its south edge had also been given a fillet, narrowing from c. 0.24 to 0.10 m as it ran towards the projection and its top flush with the base of the highest surviving course of the wall, of small brick fragments and mortar which was not removed but probably lay over the natural, [5], suggesting the level of the contemporary ground surface.

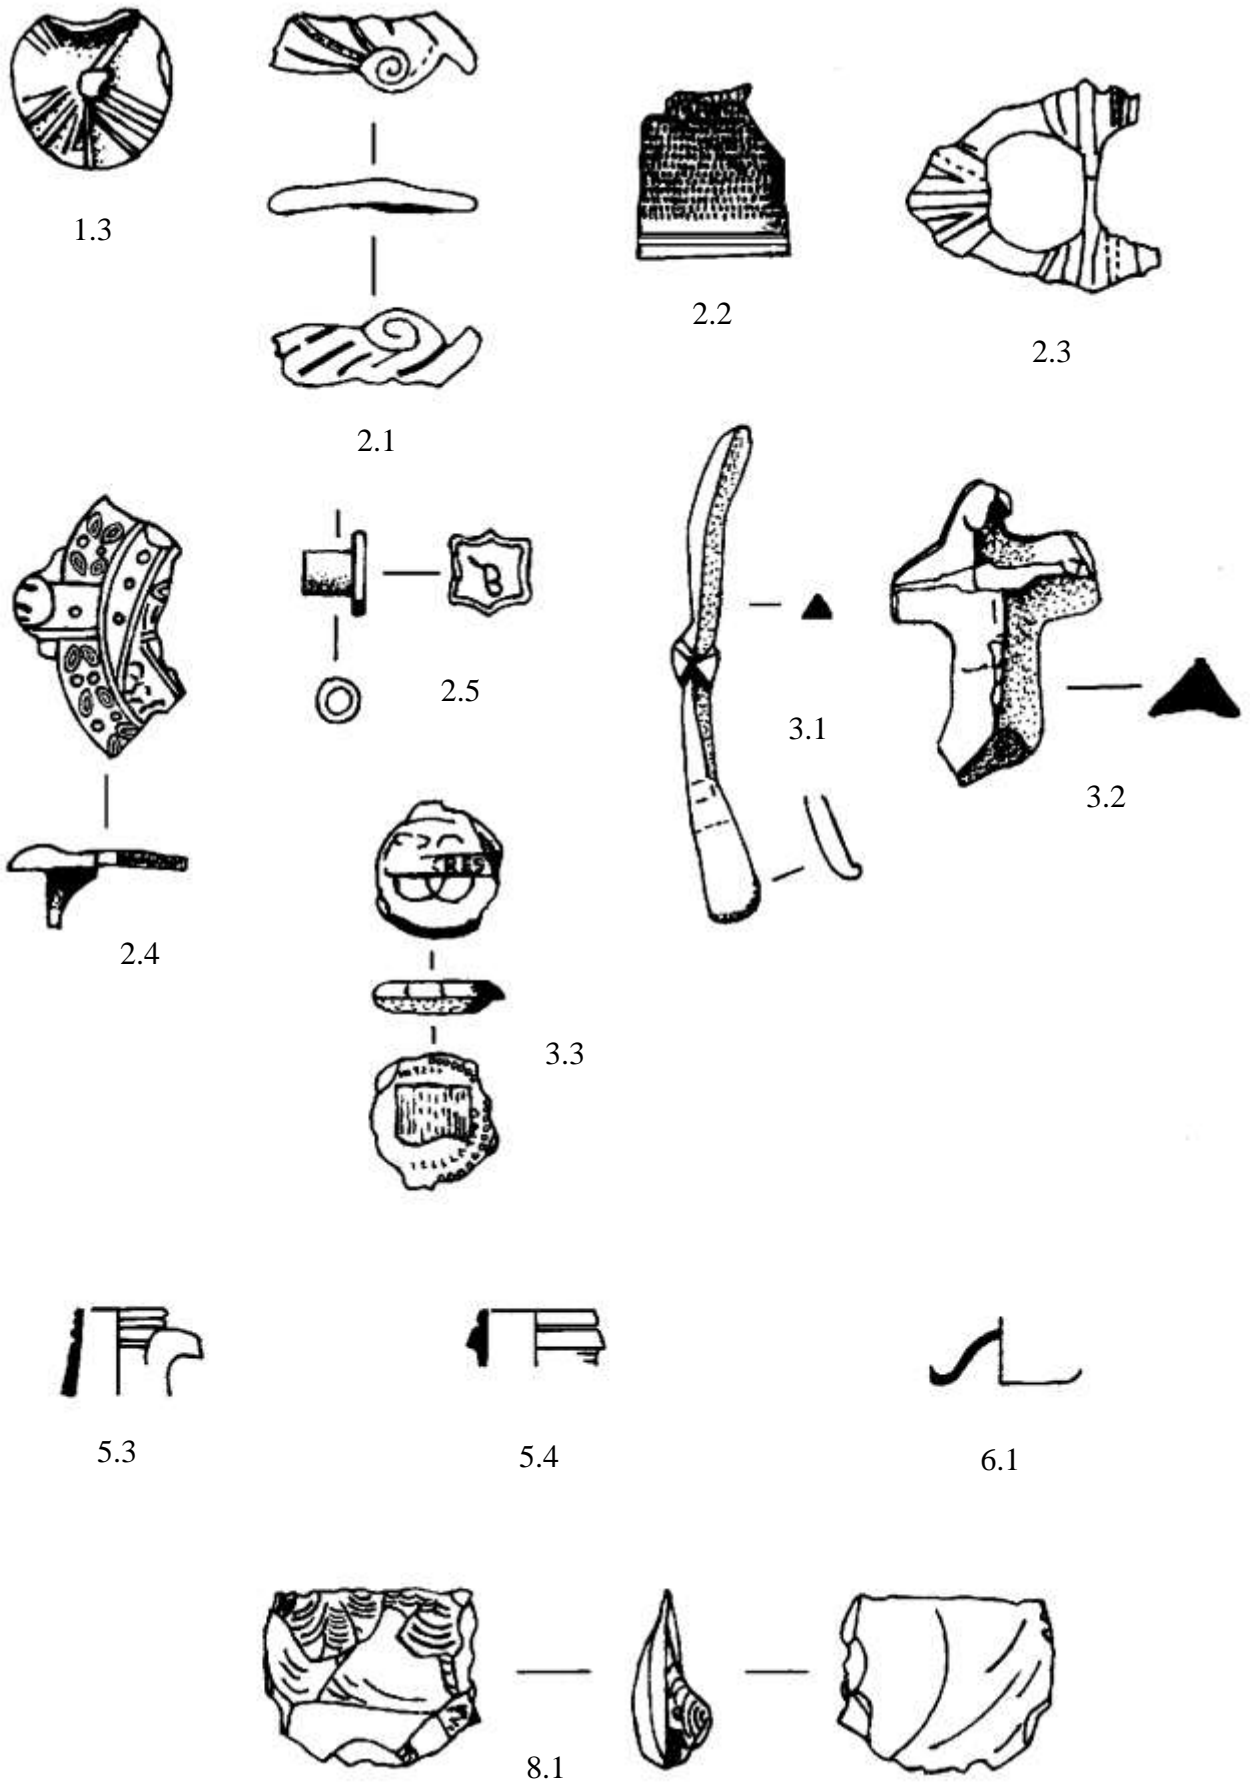
Fig. 7: Objects of Copper Alloy and Lead, Pottery, Glass and Struck Lithic (1:1 except 5.3, 5.4 and 6.1 at 1:4)

*3.1 ?Window lead tie (L. 6.60; Th. 0.31 cm). Cast triangular sectioned bar, expanding and broken at one end with a pair of small decorative pellets part way along sides. Distorted. Window lead ties were used to attach the joins of two plus comes to iron window bars (cf. Egan (2005, 357) Nos 389 – 421) and are usually D-sectioned, but triangular sectioned examples occur (e.g. op cit No. 420) and the same Nonesuch find shows that some were formed into decorative spirals where they met so pre-cast decoration need not question the identification. [U/S]

*3.2 ?Ingot (strake) fragment (L. 4.12; W. 2.73; Th. 0.80 cm). Cruciform. Triangular section, at least one arm probably cut, two others cut or broken and fourth ?drawn out and spiralled to one side. Rough tool scars to back. Grid form ingots (strakes) are better known in pewter but there are probable examples in lead (which the present item is more likely to be) stamped by the Plumbers' Company (cf. Egan (2005, 346) No. 103). [U/S]

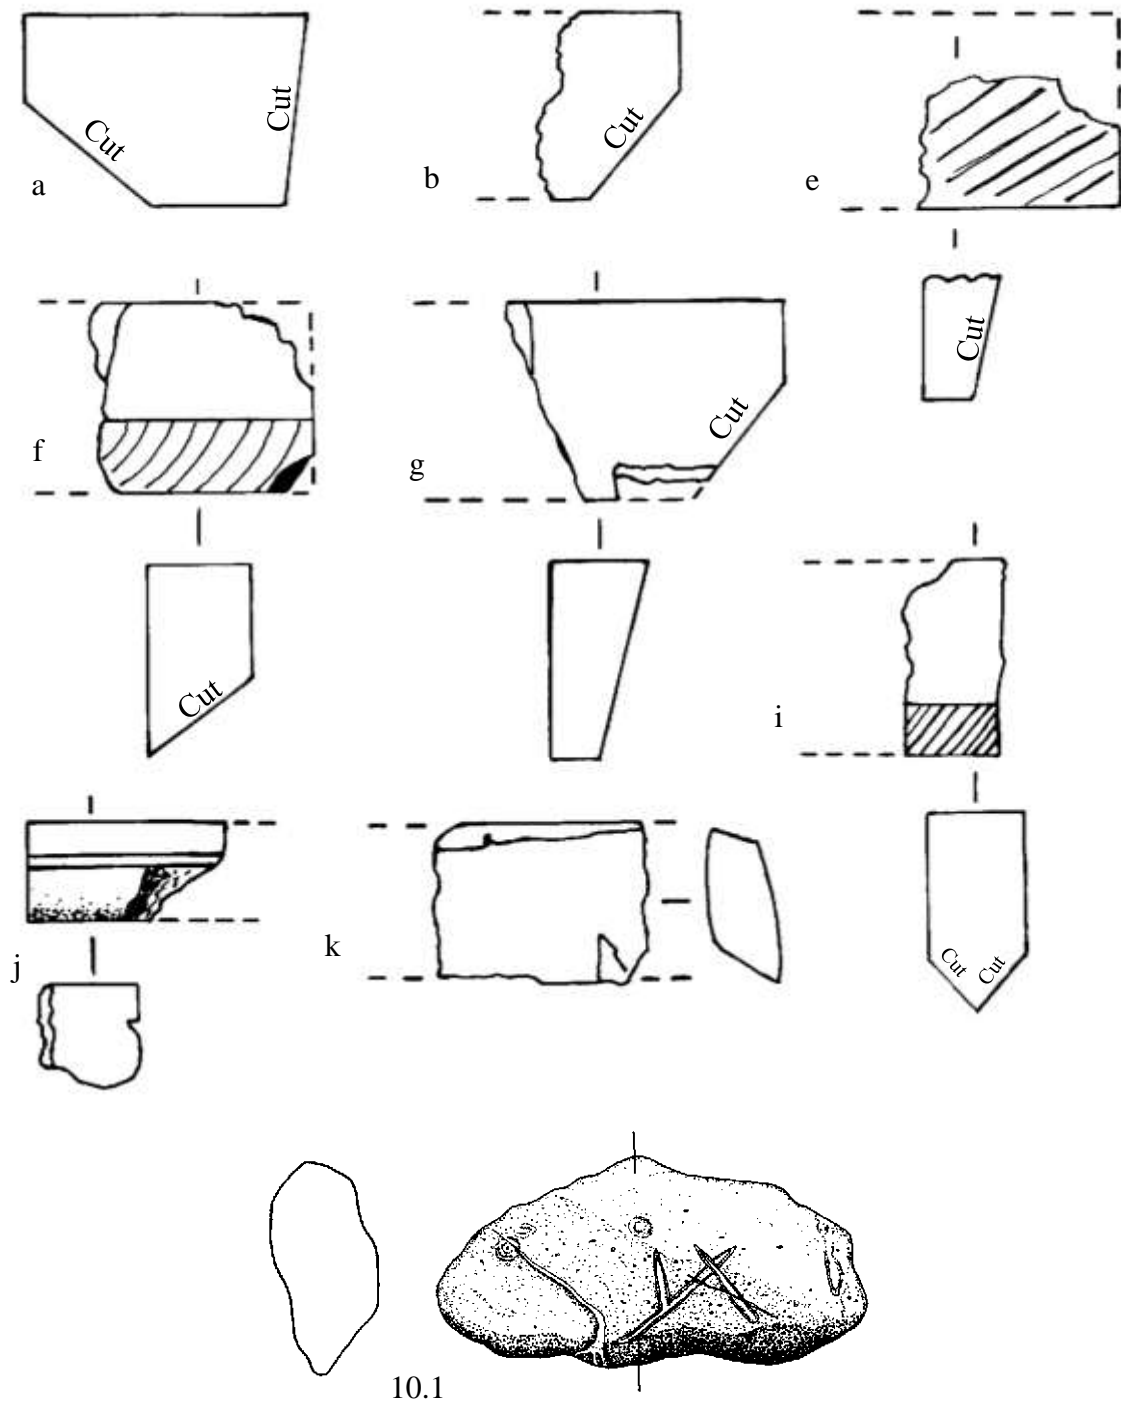
Fig. 8: Cut and Moulded Brick and Worked Stone (1:4)

10. 2 – 10.4 Three worked but very heavily abraded fragments of Greensand which may all be from the same block (largest: Max. L. 12.20; Max. W. 9.60; Max. Th. 6.20 cm). The two smaller pieces have only a single irregular edged worked surface. The larger in section has three worked surfaces surviving; the assumed vertical back and horizontal base, and the sloping upper surface. The upper surface slopes down from the assumed back of the block to a broken edge and is heavily abraded suggesting it was sited on the exterior of the building and suffered from water erosion. It could have formed part of a stone plinth course, a dripstone from over a door or window or part of a window sill. [3]

In addition to the *in situ* Queen Closers noted in the description of [11], ten certainly cut or moulded bricks and two further possible examples were recovered from [3], [6] and [13] and appeared to represent at least six different categories of material as follows.

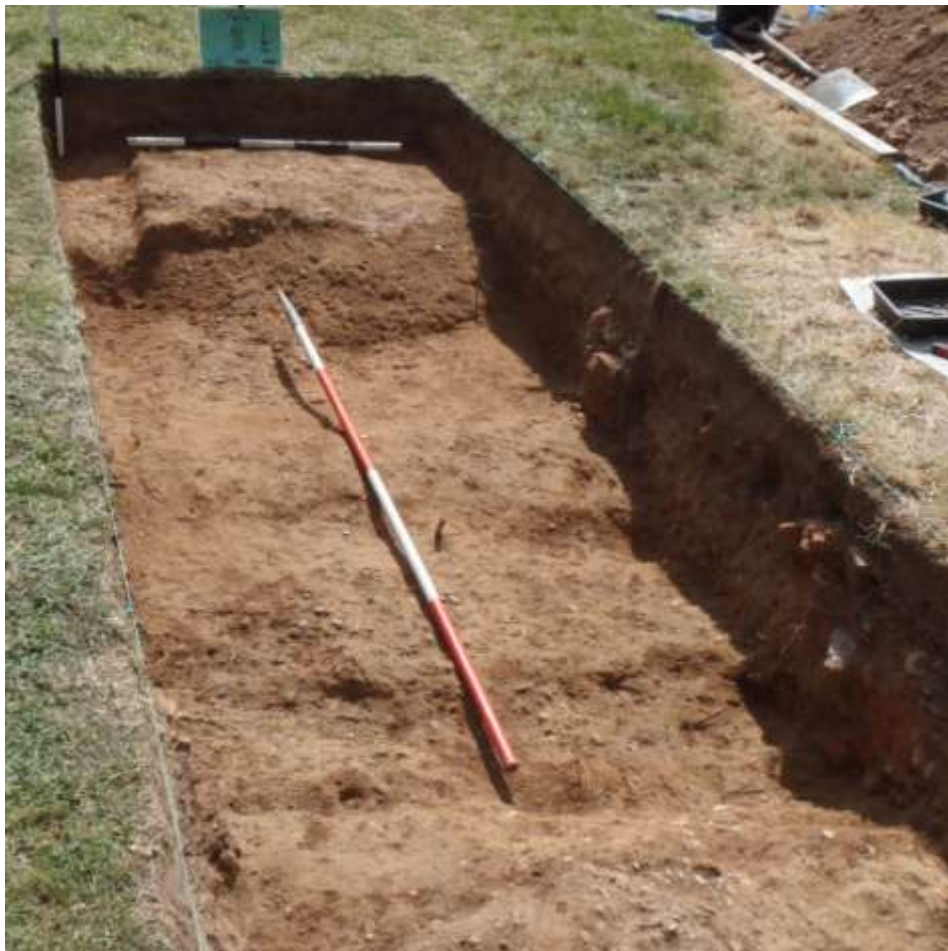
Pl 1: Outer ?Moat [4] Looking North (Photo Neil Pinchbeck)

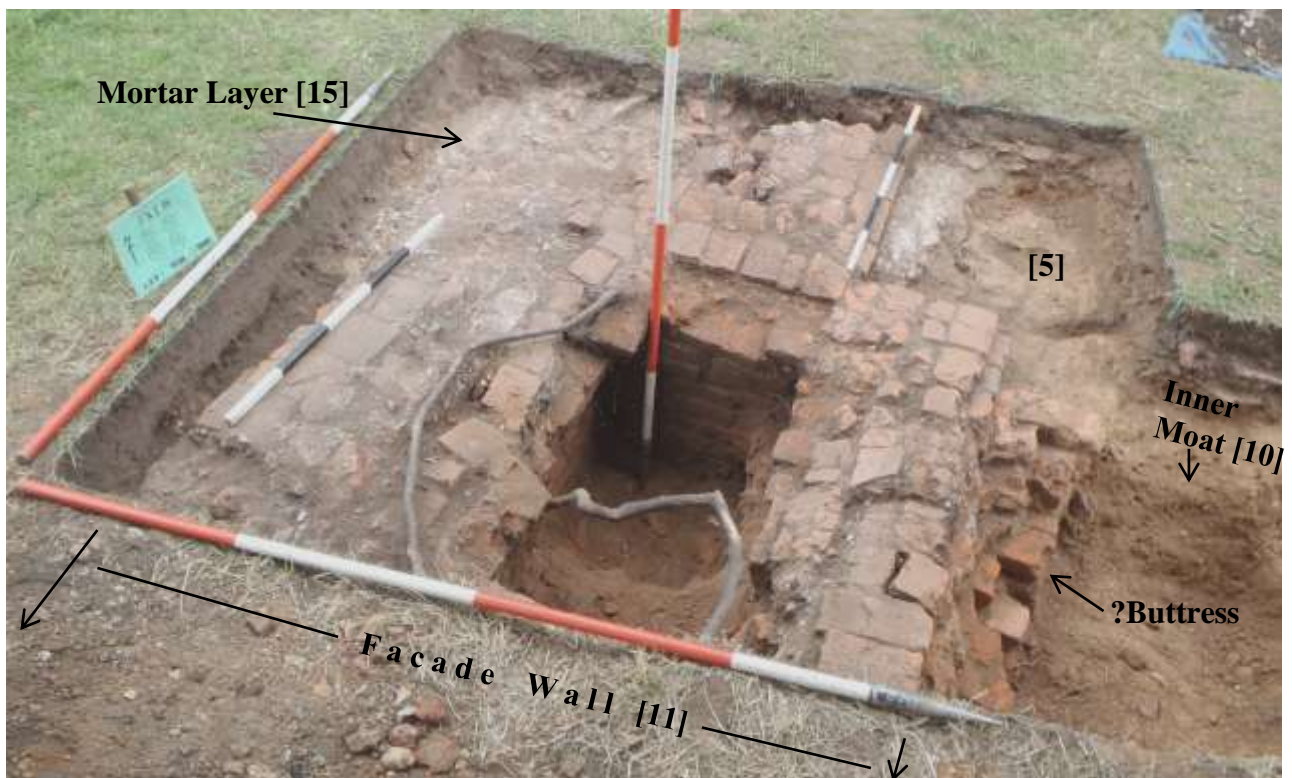
Pl. 2: Inner Moat, Facade Wall, Garderobe Chute and ?Floor Looking East (Photo Neil Pinchbeck)

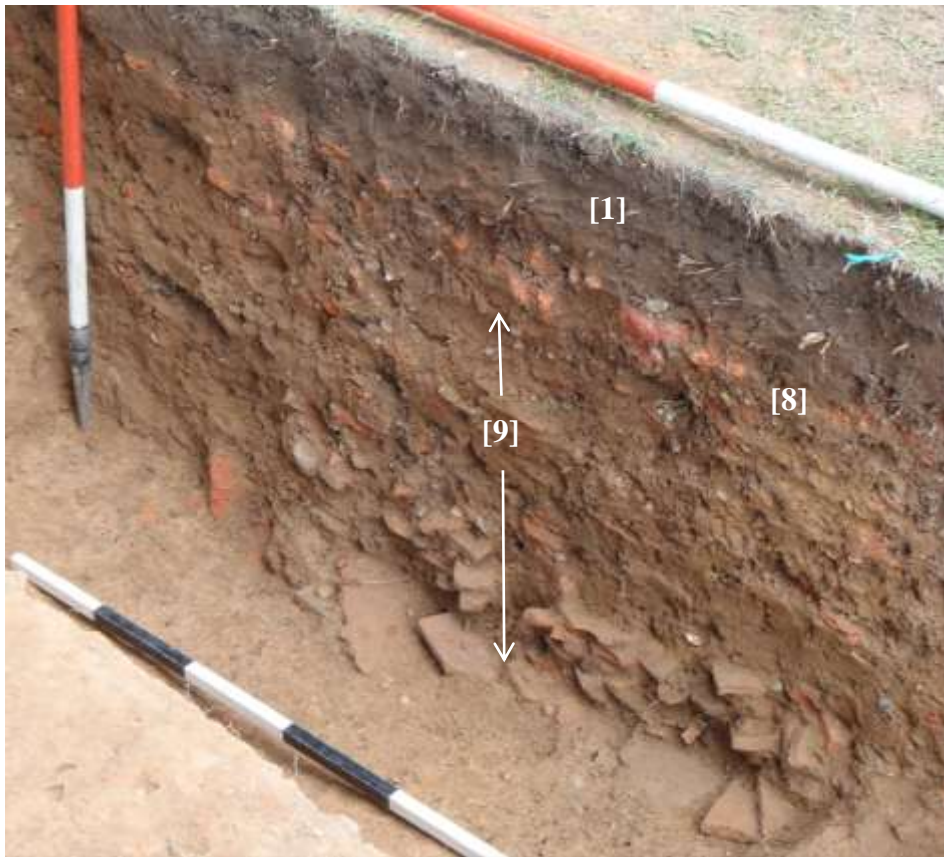
Pl. 3: East Section of Inner Moat Showing Fills [9] and [8] (Photo Neil Pinchbeck)
