Excavation at Elsyng Palace, July 2016 (Site Code FXL16)  
by Martin J. Dearne

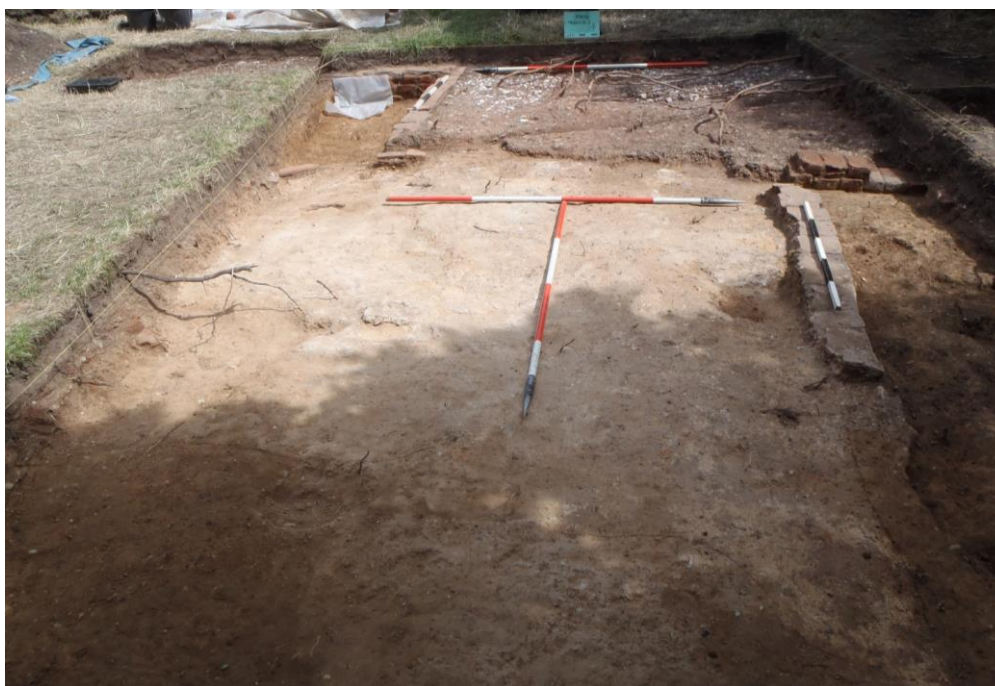
Looking North over the Room that had a Glazed Tile Floor, with the Trapezoidal Room to the Right and the ?Service Area and Stairwell (top left) Beyond

But when we had done so we had layed out before us not just the plan, but also some of the floors and a complete stairwell from what was clearly in fact quite a large (how large we are not yet sure) at least two storey building, probably of moderately high status, but quite probably timber built on dwarf brick walls (half timbered is the slightly misleading technical term).

Just behind the facade was a long room which had a mortar base for its floor of glazed tiles (hundreds of fragments of which came from the demolition material). Separated off from it by a timber partition which had been founded on a low wall built of mortar and roof tiles was a smaller trapezoidal room which had had any floor removed by large demolition cuts. To their north a change to a rammed pebble and chalk fragment floor, which was still largely in place, showed where what was probably more of a service area began. And projecting into it was a complete stairwell that had led off of the first room. Its edges were defined again by dwarf walls built as much of mortared roof tiles as bricks and which would have carried timber constructions to support and box in the stairs, which were also supported by a central possible newel post foundation. On the east the trapezoidal room had slightly sturdier east and north foundations of brick, though still probably only for half timbered walls. Whether the eastern of these was an external wall was unclear – and determining that must await further excavation – though either way there was a badly damaged cobbled surface beyond.

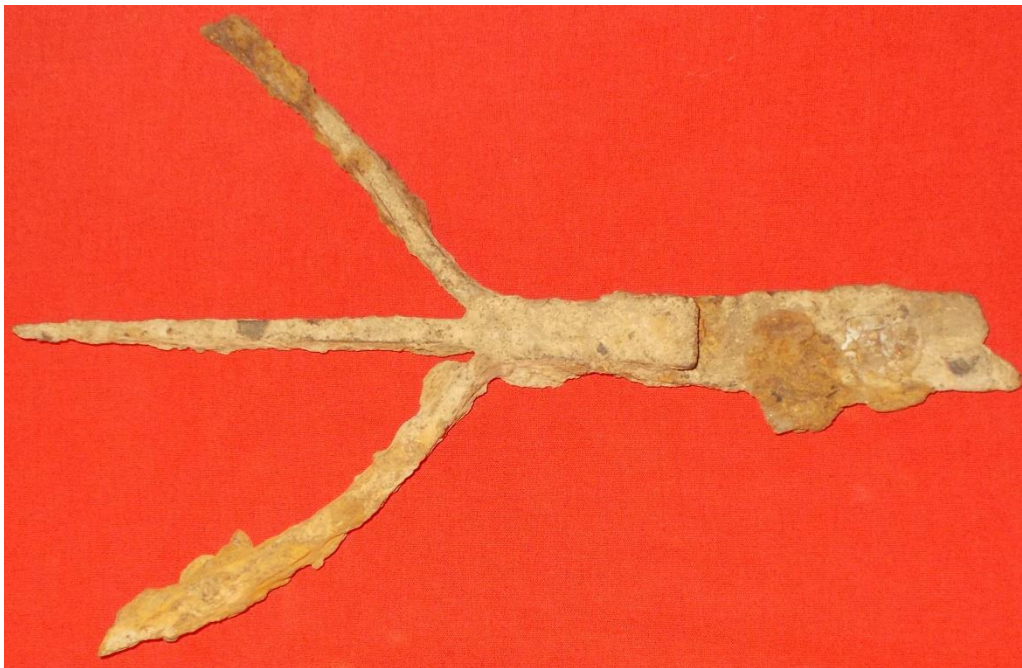
Iron Roasting Spit (Length 29 cm)

The demolition rubble provided hints of some of its fittings with parts of moulded brick window surrounds, a fragment of coloured window glass, window leads, parts of a brick column base, small fragments of carved stone and some structural fittings in the form of iron bars as well probably as chest bindings. However, demolition rubble of course reflects the state of – and the portable items within it the use of – a building not when it was built, but mainly when it was knocked down. And we know the palace had been out of royal hands for decades by then and parts of it were probably rented by its main owner to a number of well to do but hardly royal tenants. Quite likely it was they and their servants that had left behind a lot of the pottery and other small items found including jettons (counting or gambling tokens), the head of a carved bone hairpin, copper alloy dress pins and lace tags, several large but just functional flagons, a range of salt glazed drinking jugs, the base of a glass pedestal beaker, kitchen bowls, a horse harness buckle, a sythe, iron knives and a range of food bones that suggested a relatively high status diet, including rabbit, chicken and goose, though beef and lamb/mutton may have been the most important meat elements of the diet. Indeed, an exceptional find was an iron roasting spit.
