ENFIELD ARCHAEOLOGICAL SOCIETY ARCHIVE REPORT

EXCAVATIONS AT ELSYNG PALACE, FORTY HALL, ENFIELD, MAY - JULY 2018

(SITE CODE FXQ18)

by
MARTIN J. DEARNE

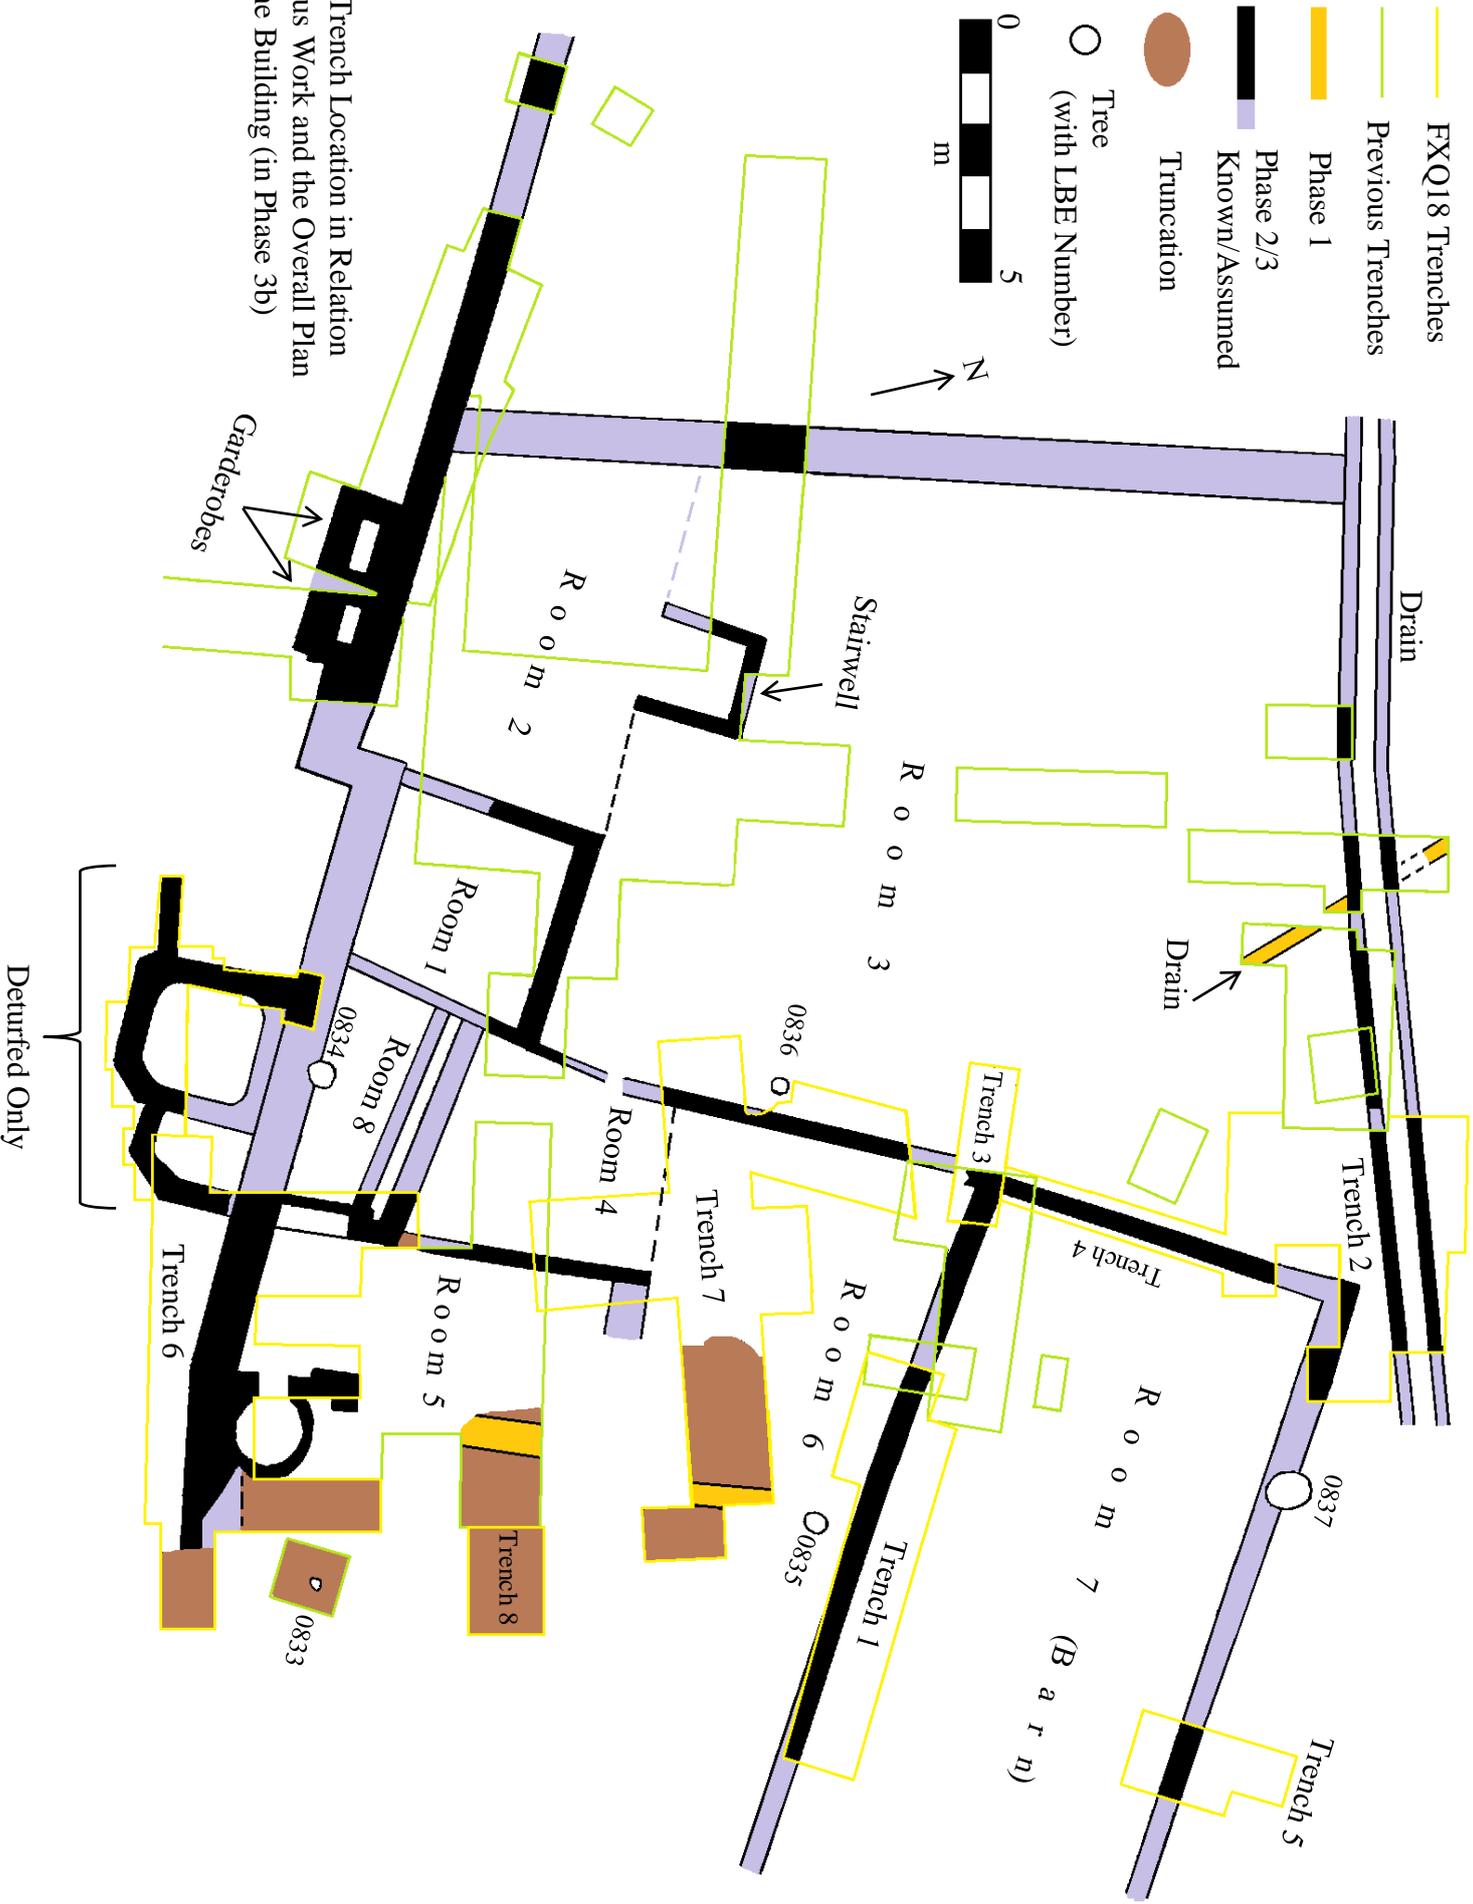
Fig. 1: Trench Location in Relation to Previous Work and the Overall Plan of the Building (in Phase 3b)

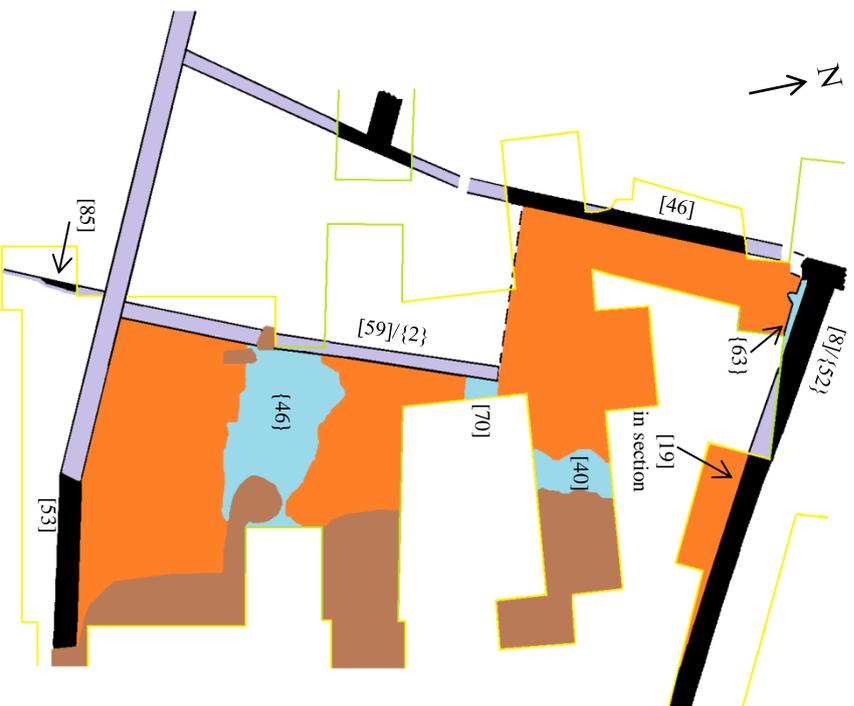
Fig. 2: Floor Surface and Tentative Structural Feature Phasing in Rooms 5 and 6; Phase 2 (1:100)

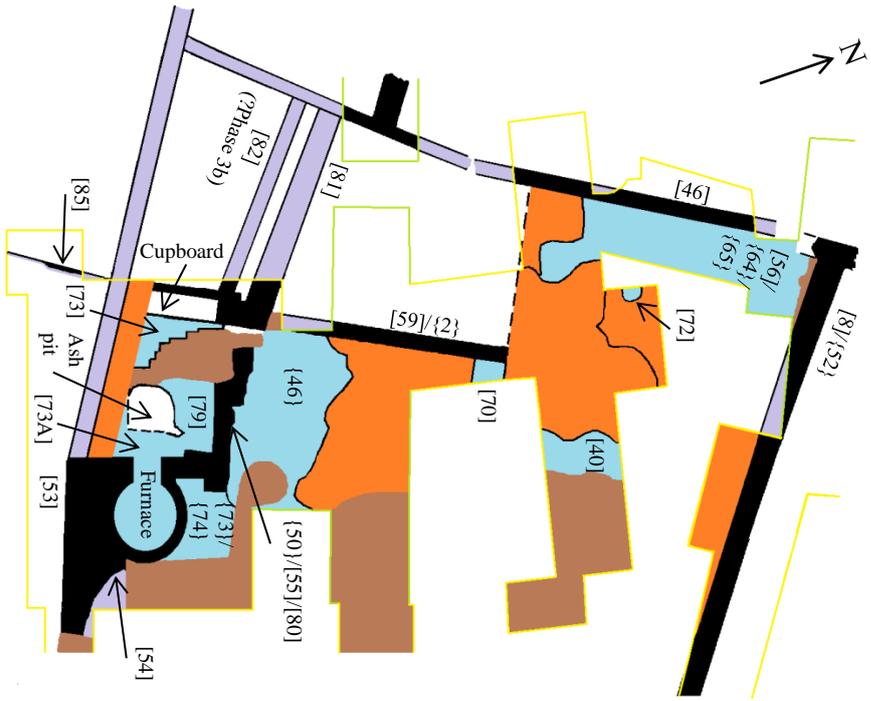
Fig. 3: Floor Surface and Tentative Structural Feature Phasing in Rooms 5 and 6; Phase 3a (1:100)

- Meanwhile in Room 5, though its Phase 2 brick floor presumably continued in use in the north of the room, it is most likely (though very far from certain) that it was in Phase 3a that major changes were made connected to the insertion of a large furnace and other features in its southern part. However, whether a new section of facade walling, [76], belonged to later modifications or were part of this Phase 3a scheme it is very hard to be sure and their discussion under Phase 3b not 3a reflects only very tentative conclusions based on quite inferential evidence. As noted above (and see Dearne 2017c, 12) though a large circular or D-shaped feature at the south end of original floor FXO17 [46] may have been removed and its site covered by an area of edge lain brick flooring (FXO17 [47]) intended to disguise its former position, though the only part demolished foundations of this structure (FXO17 [60]) may have been utilised as the base for a new structure associated with the new furnace.

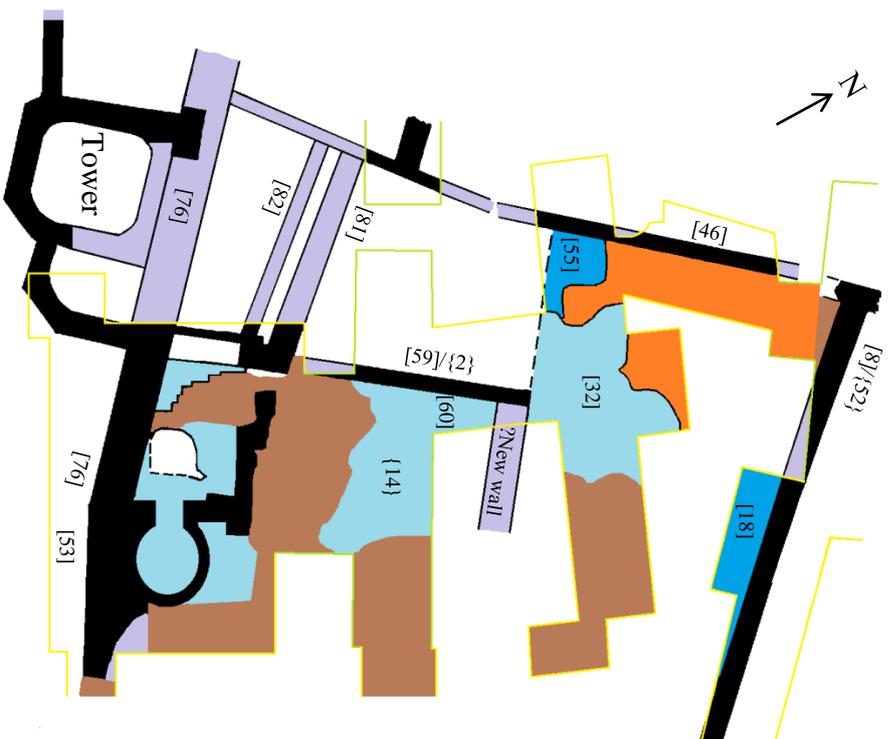
Fig. 4: Floor Surface and Tentative Structural Feature Phasing in Rooms 5 and 6; Phases 3b and 3c (1:100)

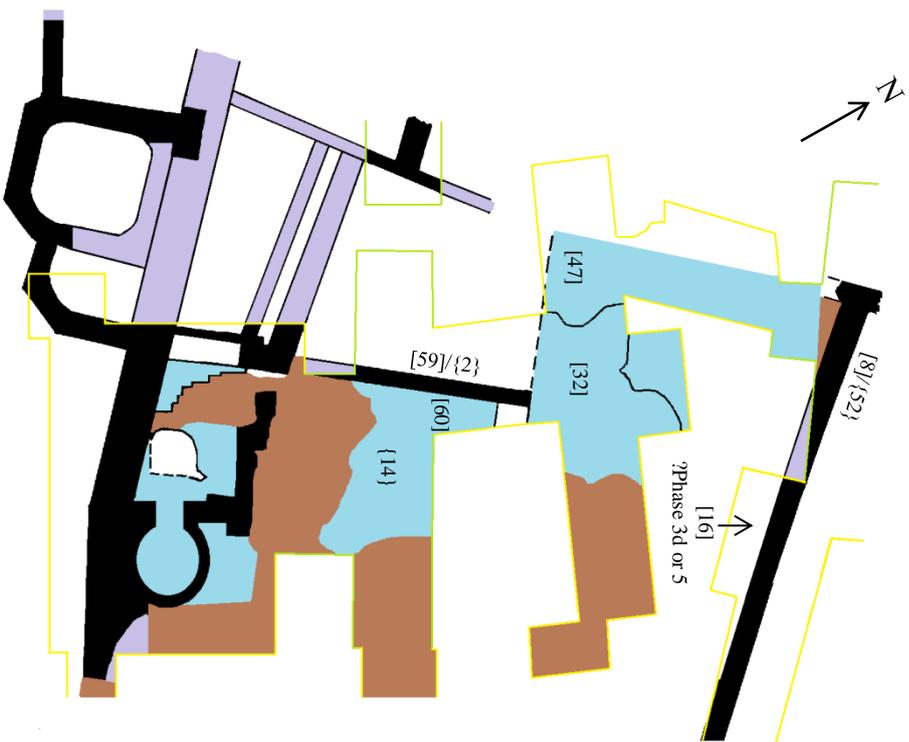
Fig. 5: Floor Surface and Tentative Structural Feature Phasing in Rooms 5 and 6; Phase 3d (1:100)

- What seems to have been the final phase of the use of and alterations to this part of the building complex saw the removal of at least one and possibly two walls so that there was now no formal division between Rooms 3 and 6 and perhaps 5 and 6 and a more widespread re-flooring of parts of the north west of Room 6. Phase 3c floor [55] had by now probably slumped to the east of wall [46] while further areas of the Phase 3b floor [32], though a fairly large area of it was probably still in use if with increasingly ragged and irregular margins to the surviving part, were now likely too damaged to use and so were removed down to the Phase 2 floor [56] across an area at the north west corner of the room. At the same time the timber wall which stood on [46] was clearly removed and it may have been that the wall between Rooms 5 and 6 was as well (see above).

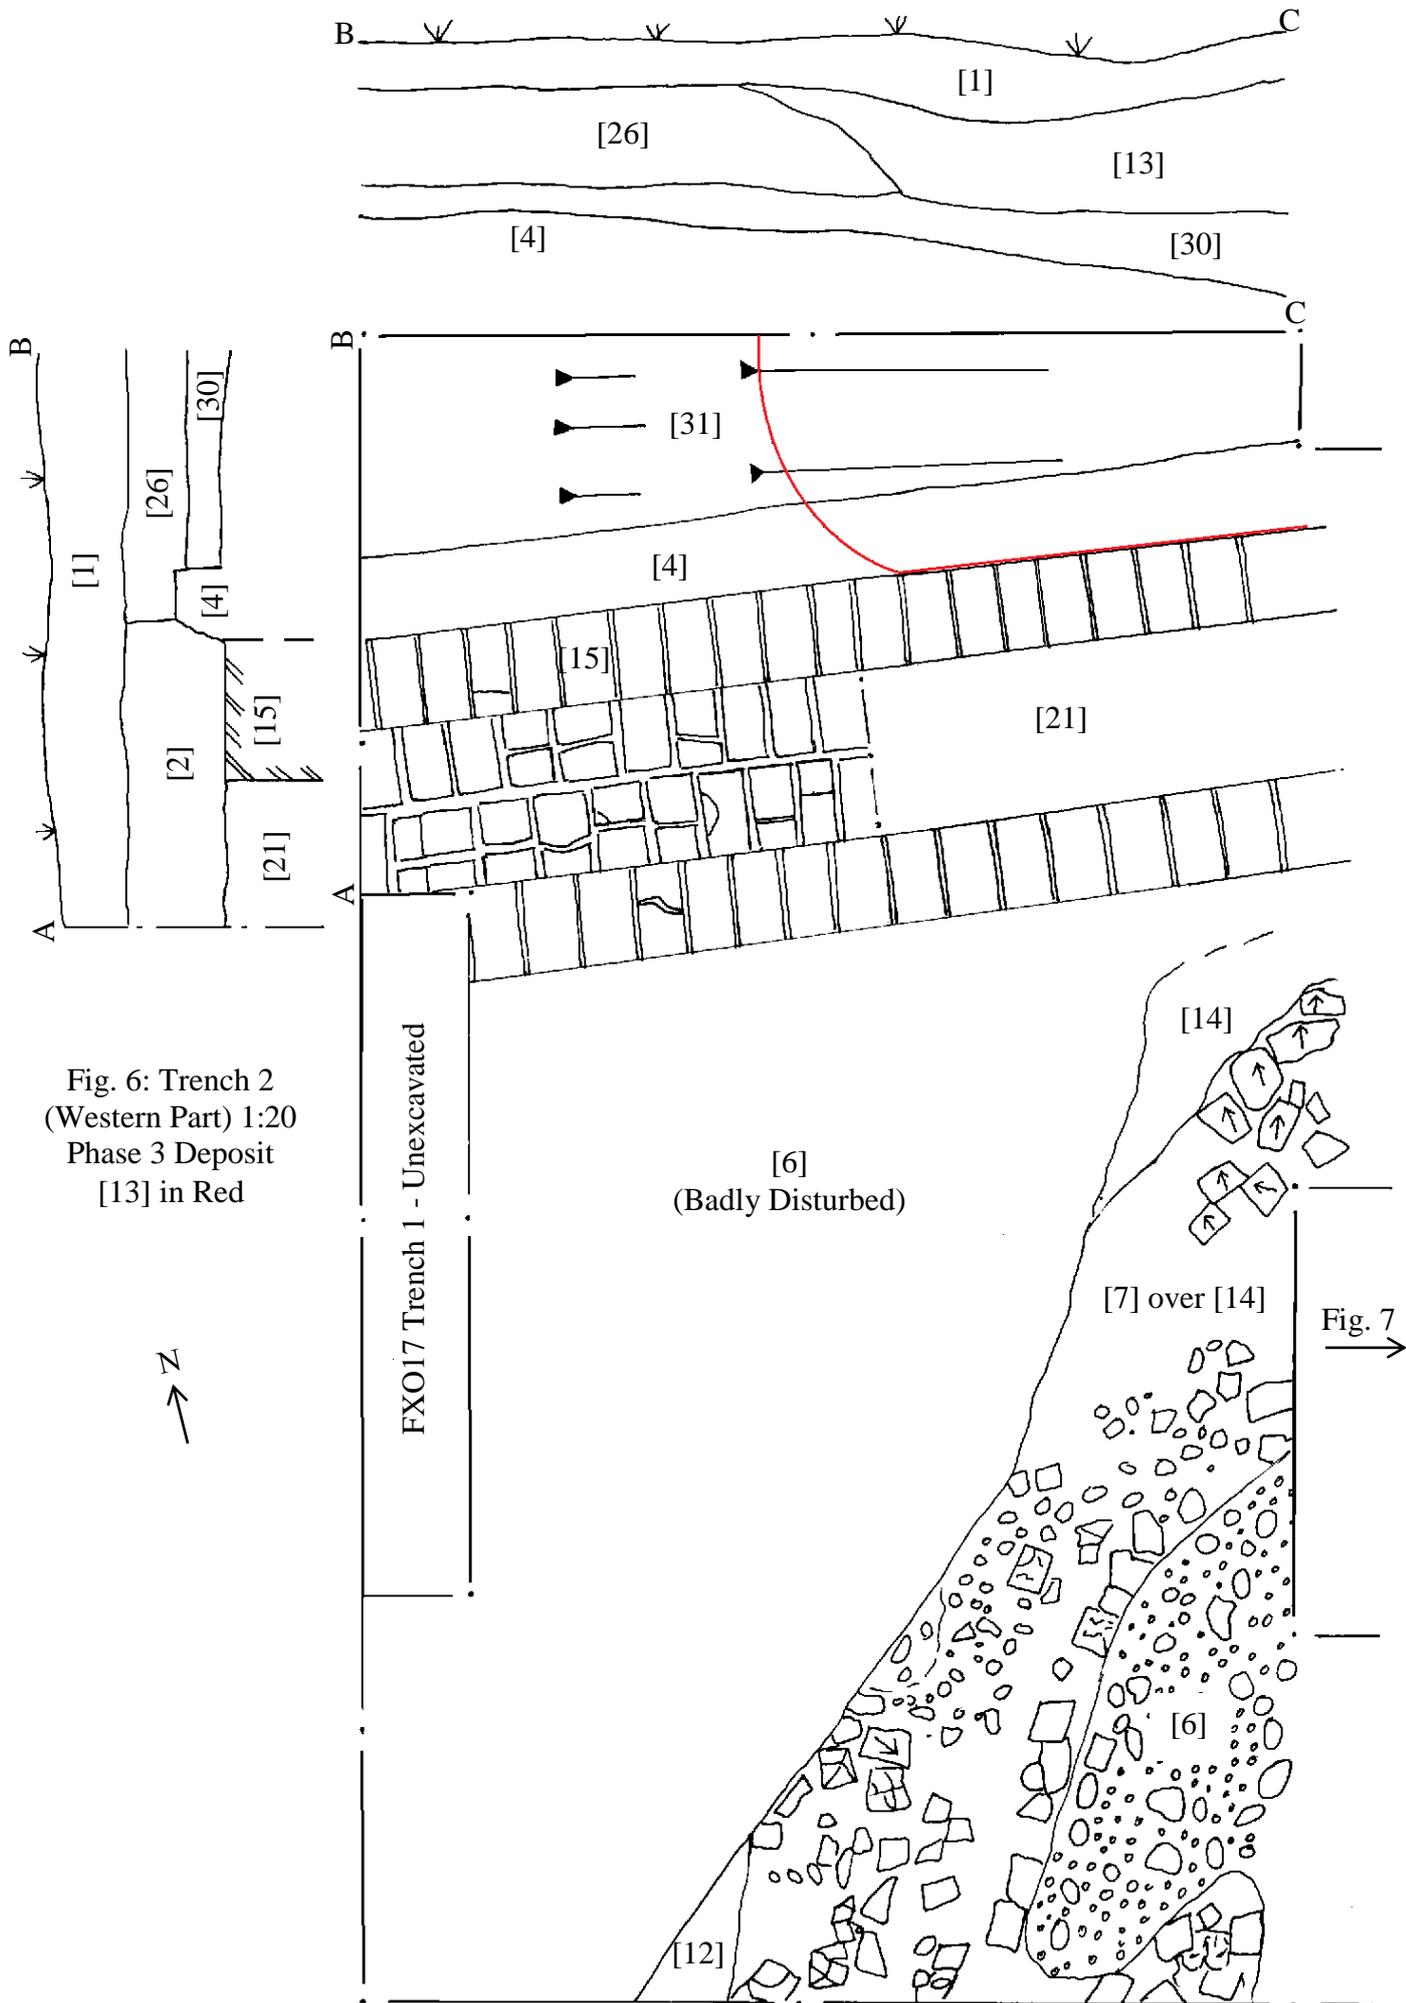
Fig. 6: Trench 2
(Western Part) 1:20
Phase 3 Deposit
[13] in Red

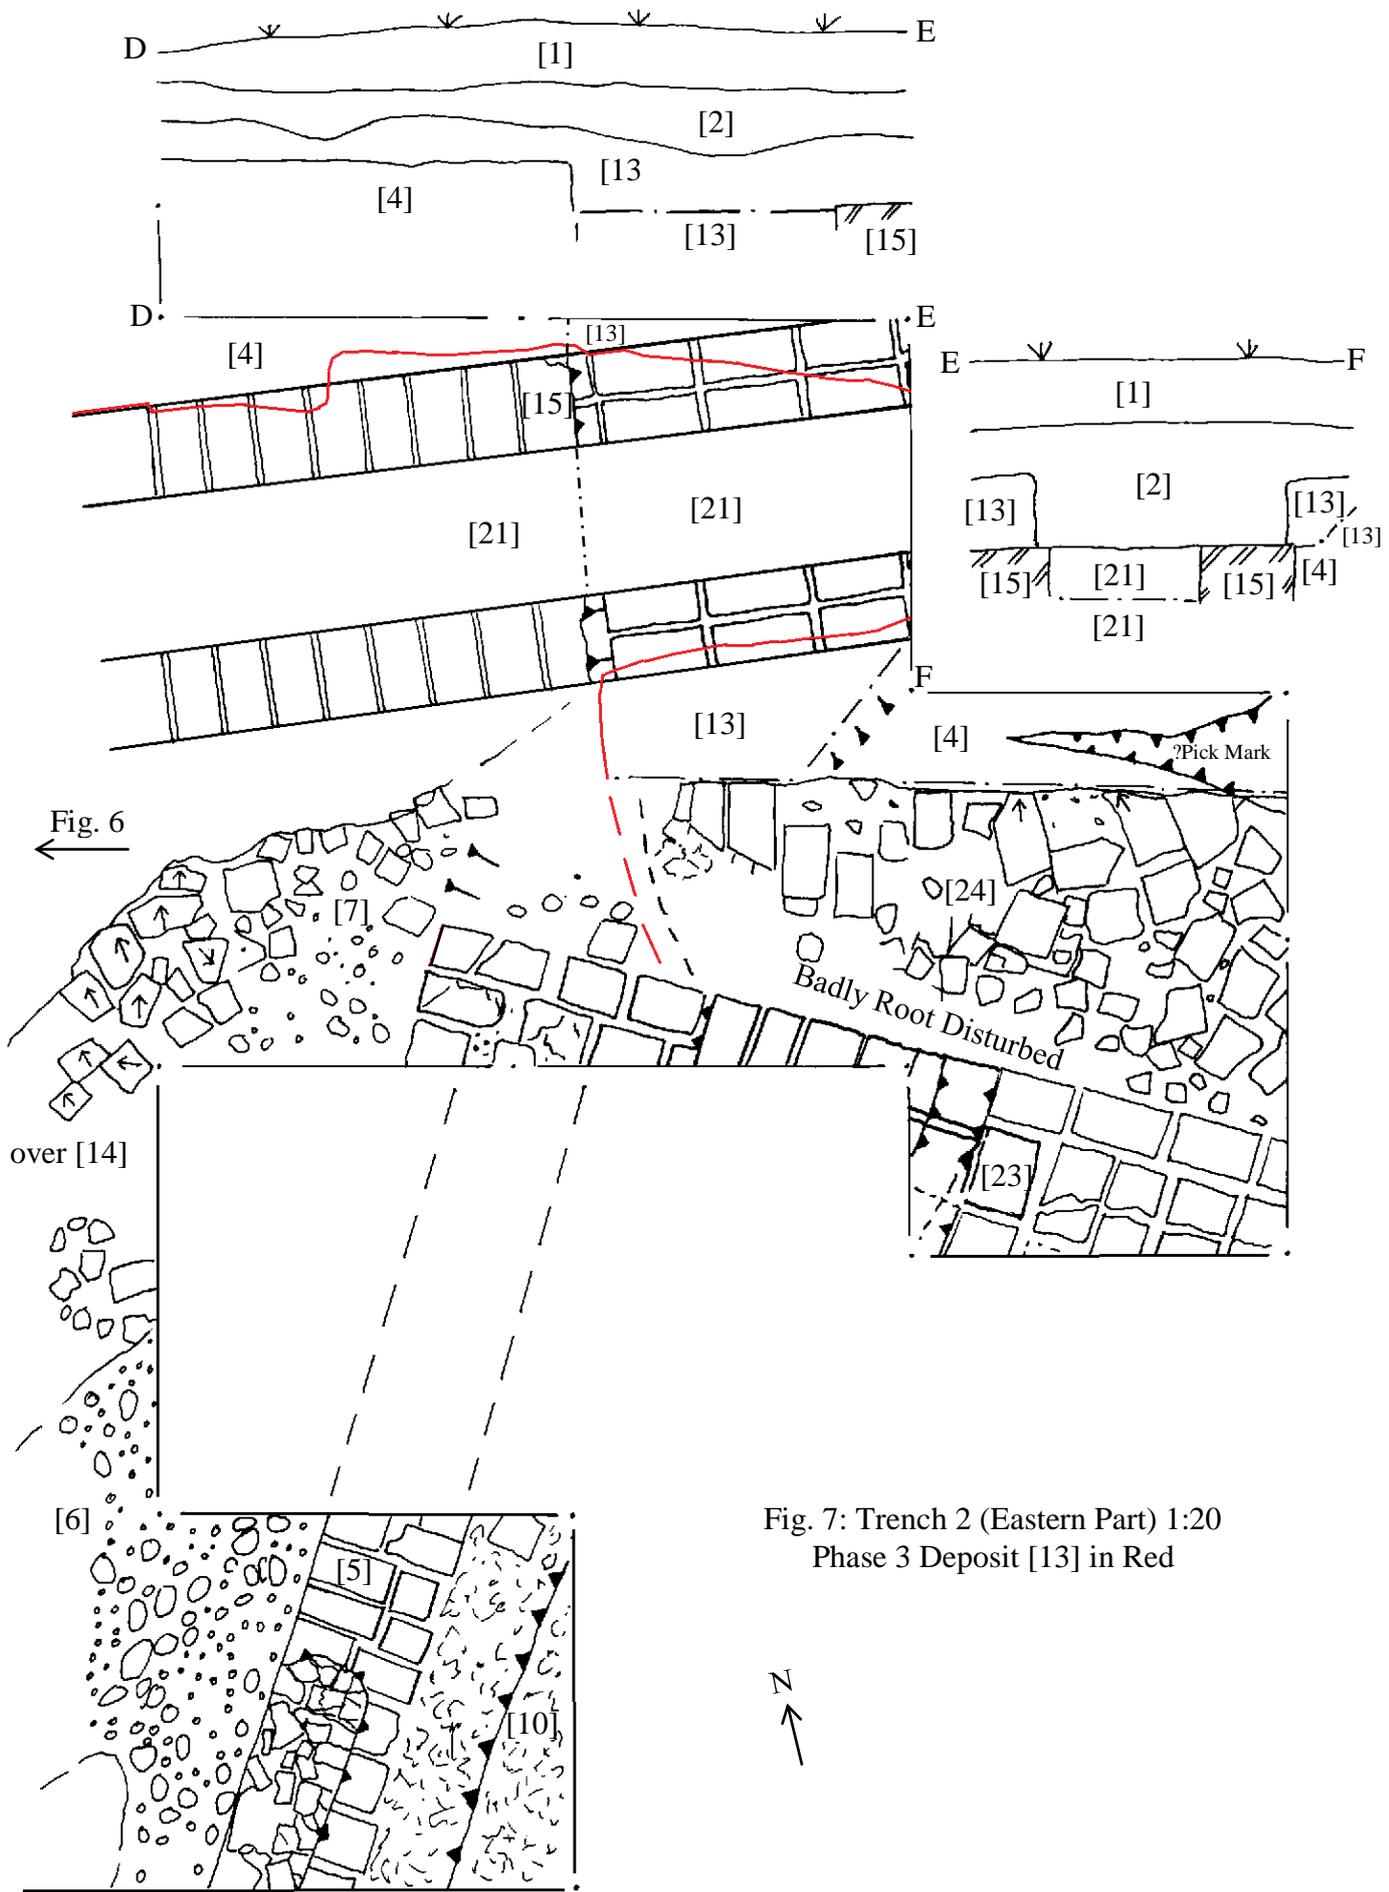
Fig. 7: Trench 2 (Eastern Part) 1:20
Phase 3 Deposit [13] in Red

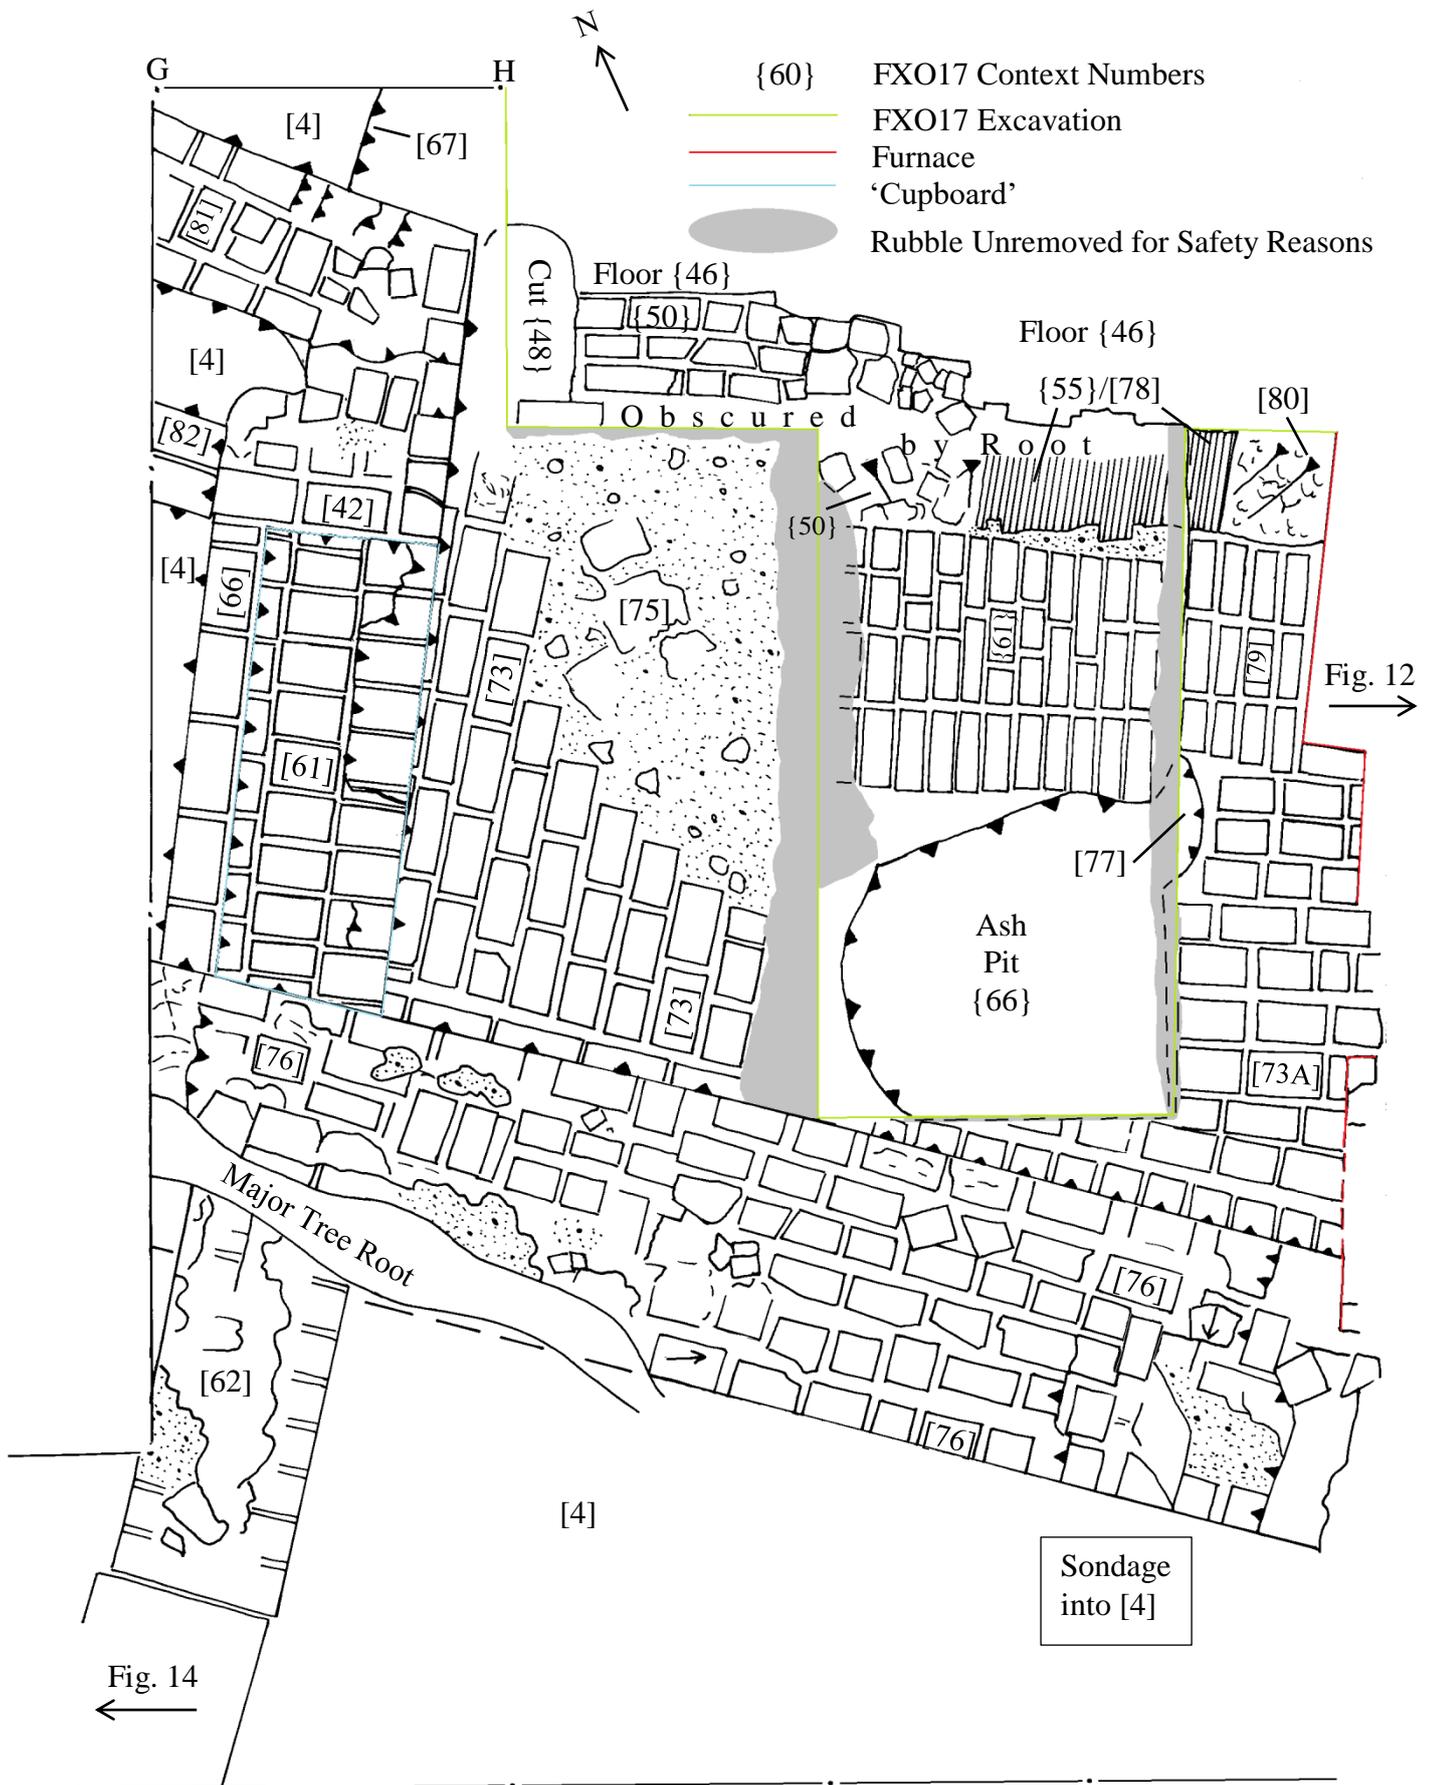
Fig. 11: Trench 6 (Western Part) and Southern Parts of FXO17 Trench 2 (1:20)

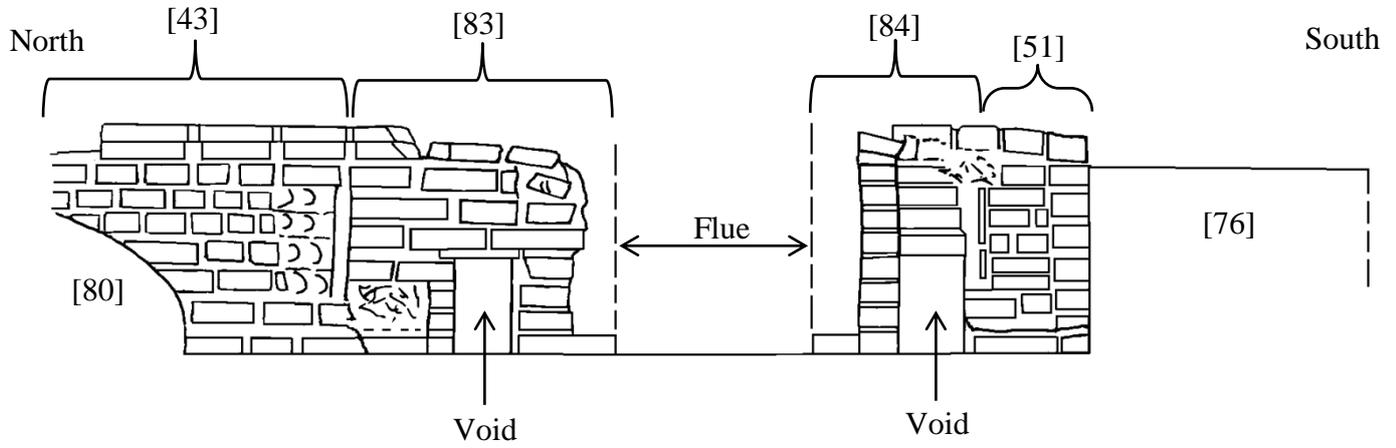
Elevation of the Western Side of the Furnace

(NB Many Details of this Elevation are Uncertain Due to Damage and it is a Partial Reconstruction)

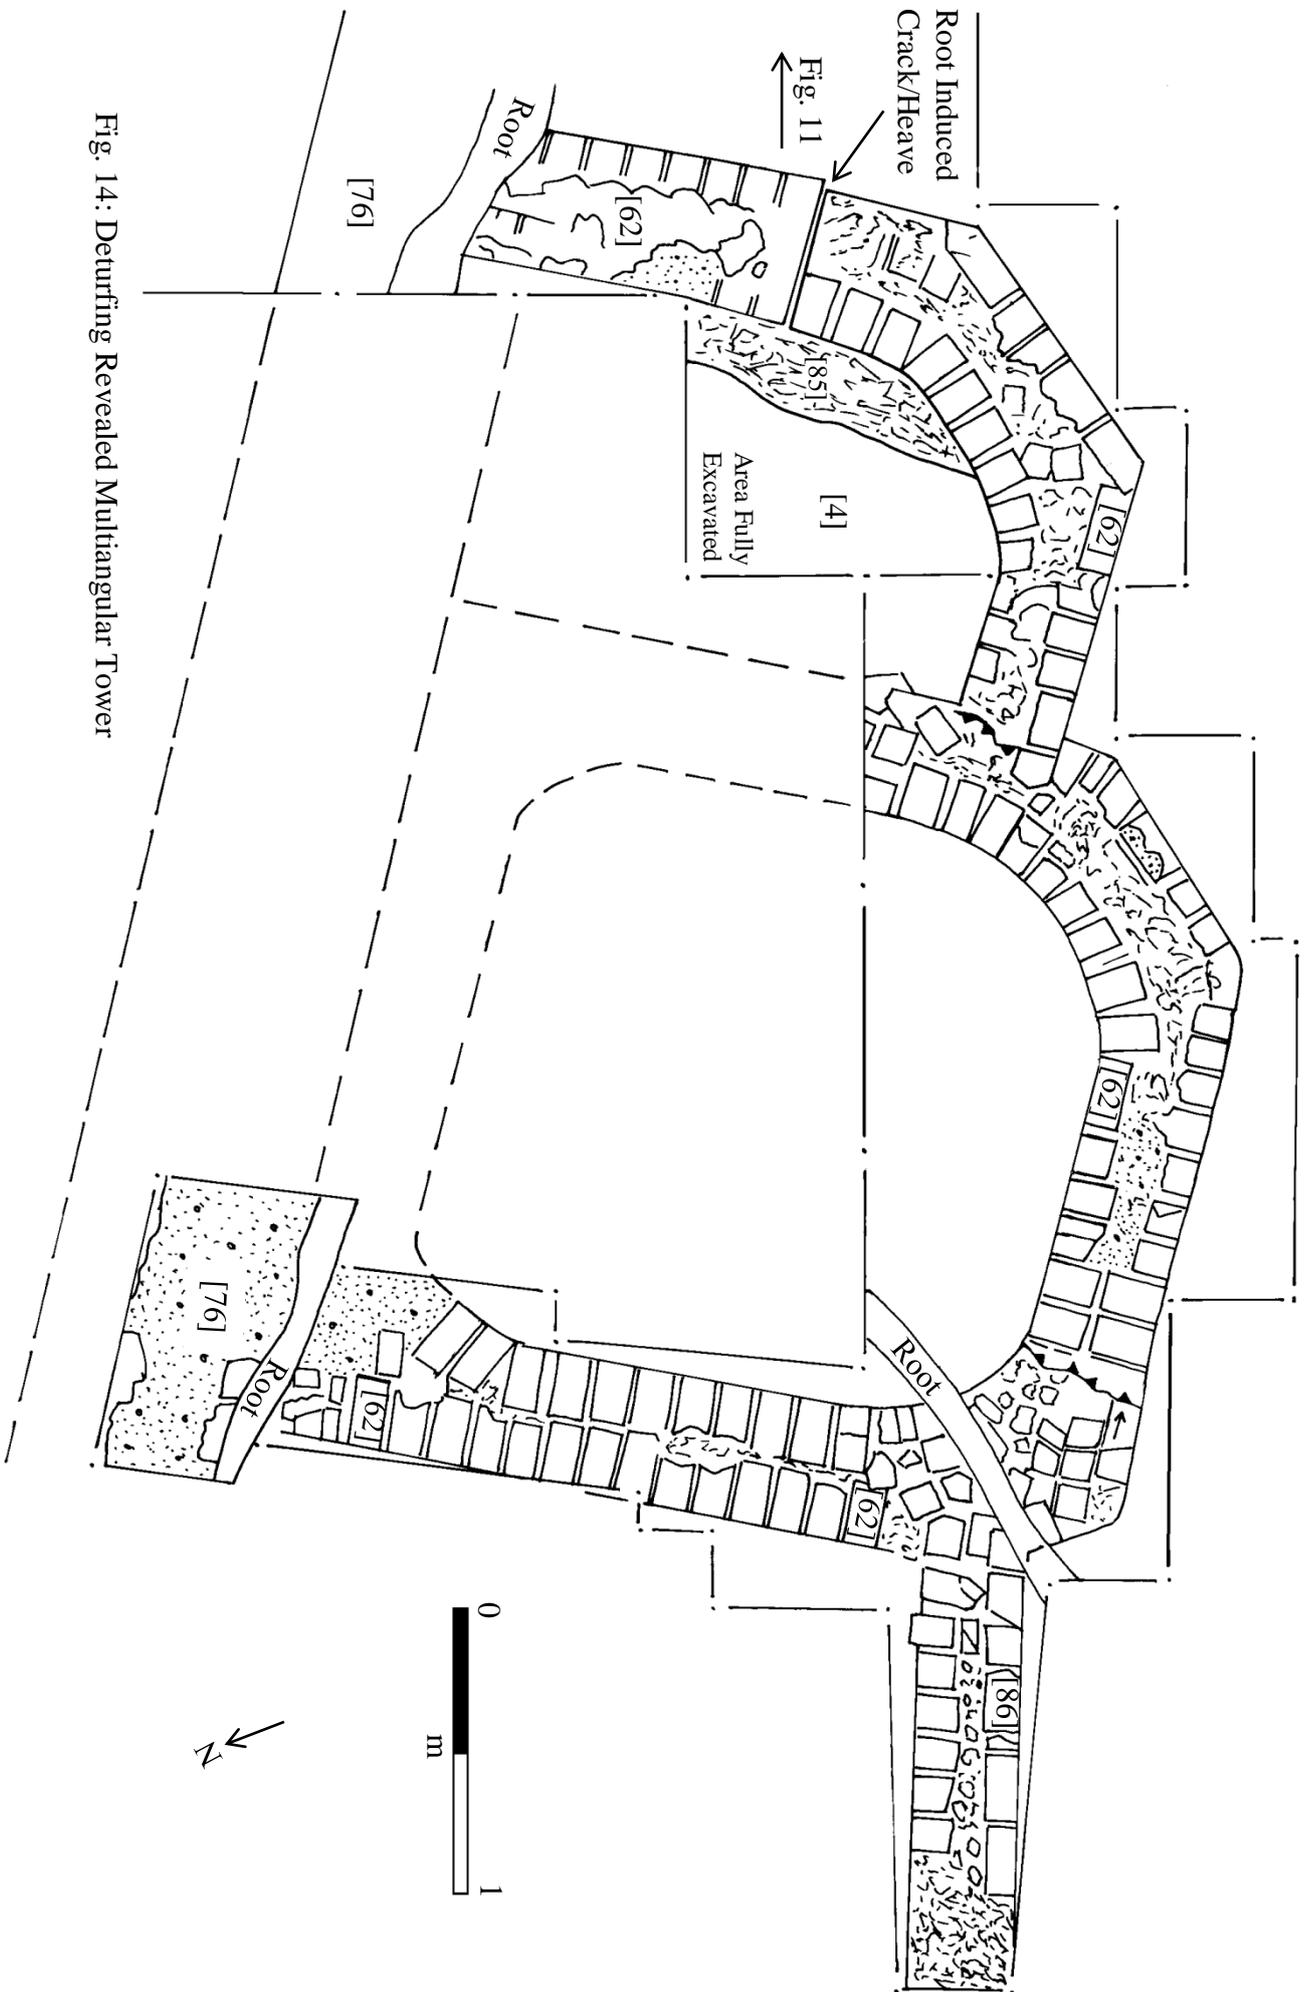
Fig. 14: Deturfing Revealed Multangular Tower

- In addition an area of approximately 8.10 m² was (only) deturfed running west from the south west corner of Trench 6 in order to reveal the plan and assess the conservational condition of a tower structure which lay immediately below turf level.

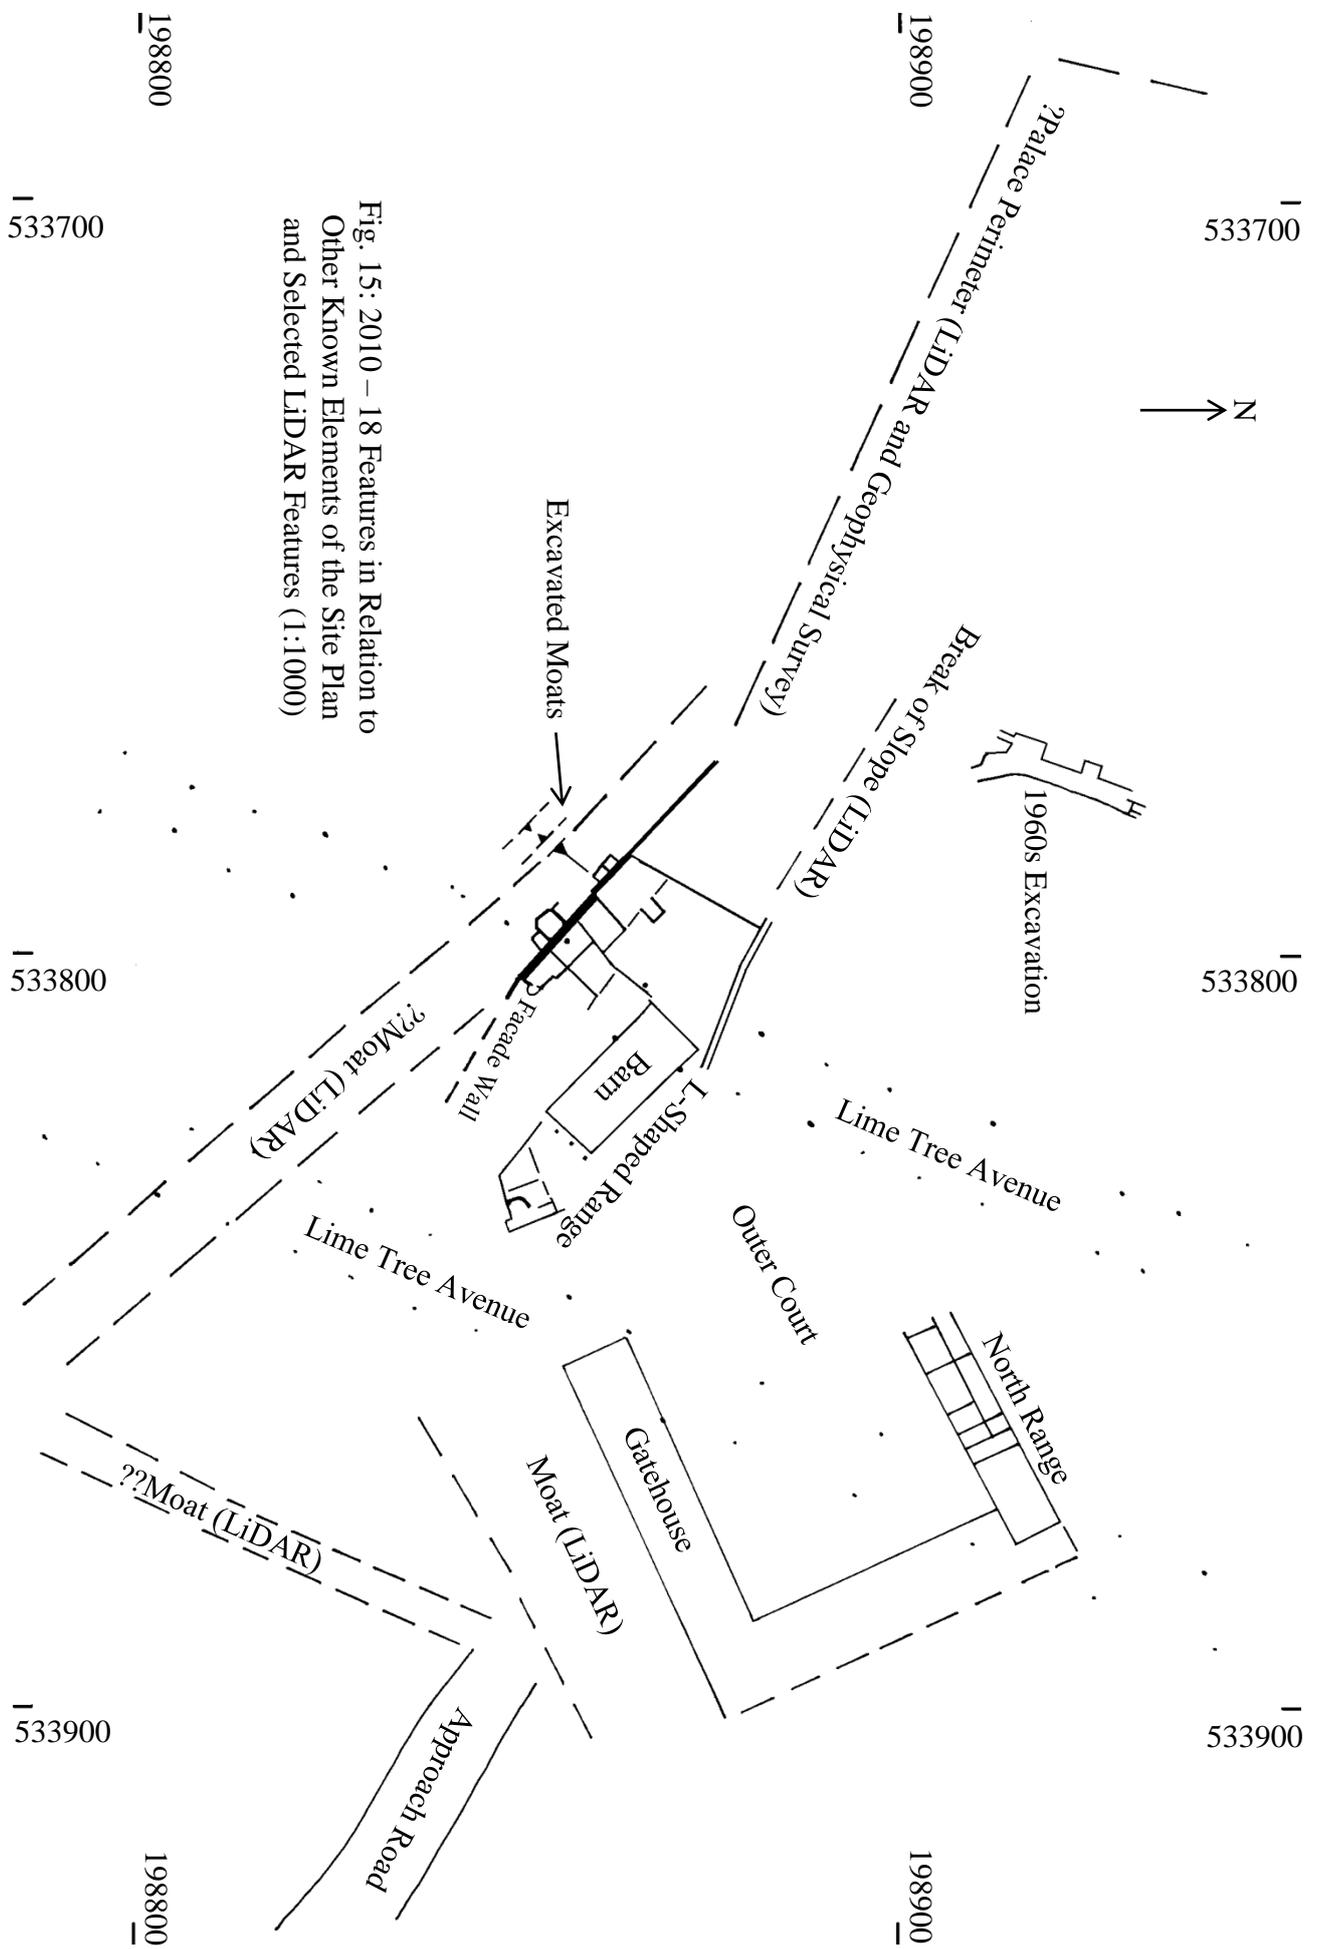
Fig. 15: 2010 – 18 Features in Relation to Other Known Elements of the Site Plan and Selected LiDAR Features (1:1000)

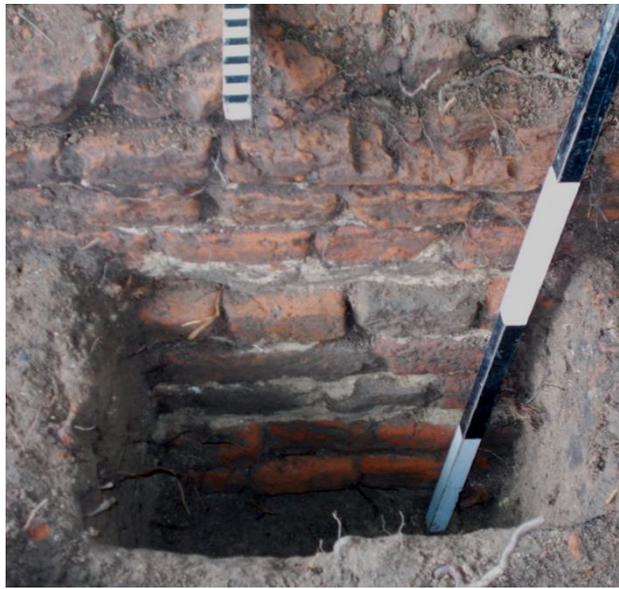
Pl. 1: South Face of Wall [8] (Photo MJD)

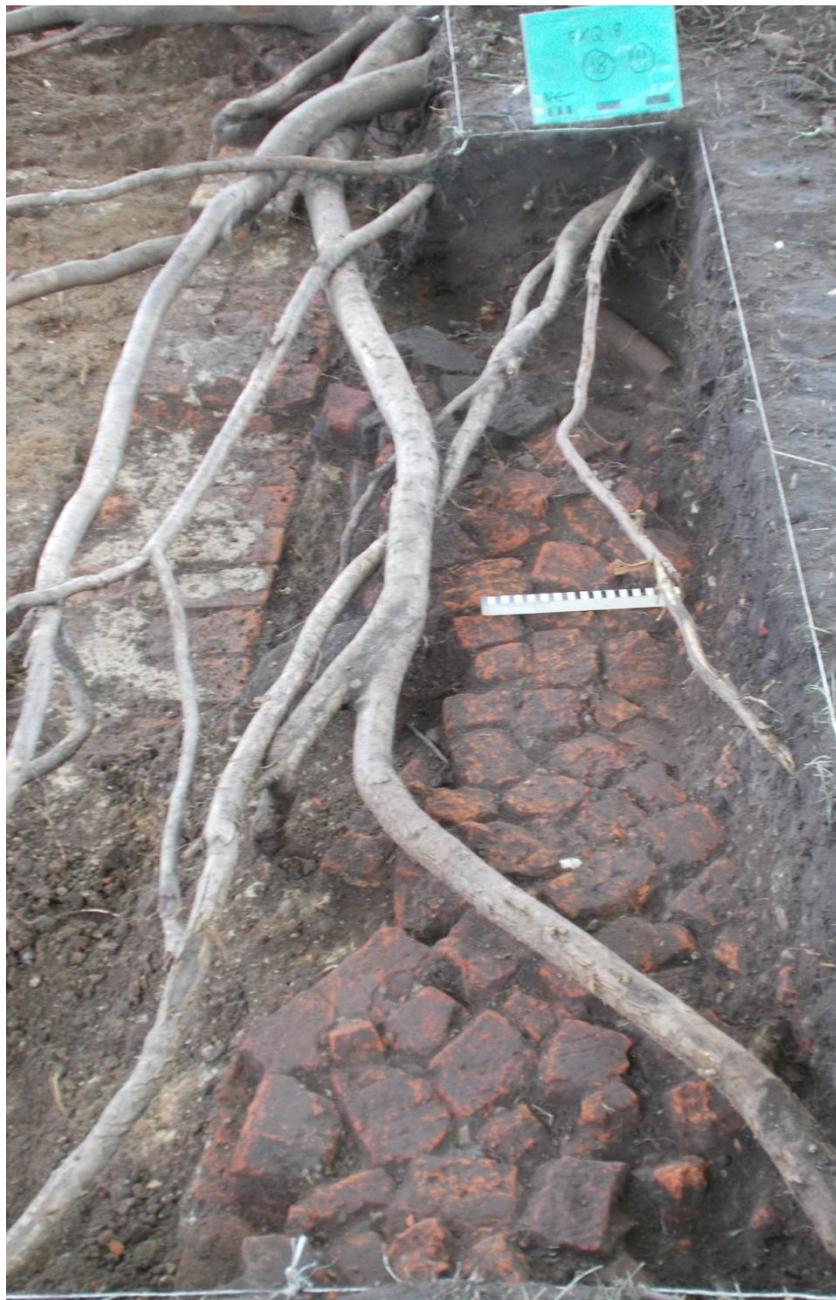
Pl. 2: Part Demolished Wall [8] and Phase 3c Floor [18], Looking East (Photo MJD)

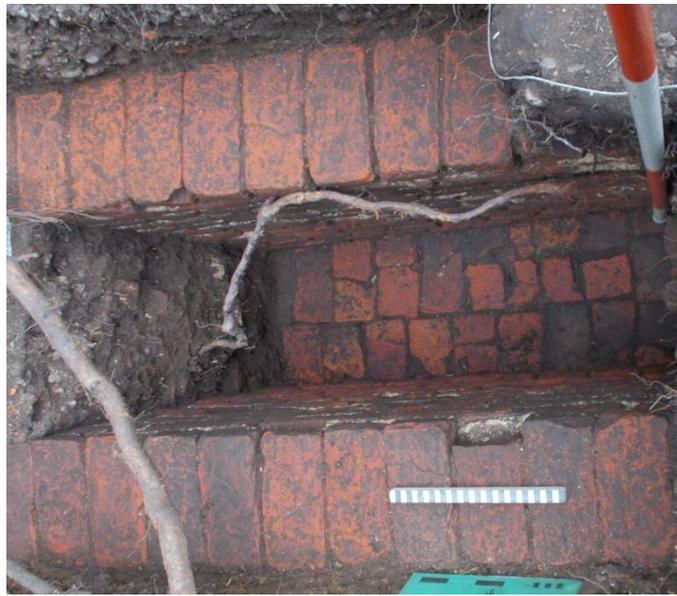
Pl. 3: Drain [15] (Photo MJD)

- By contrast in the northern part of the building relatively little brick rubble ([7]) lay on floor surfaces in Room 3 except where they had probably been damaged during demolition. However, [21], the fill of the major drain [15] at the northern edge of the building may have been of Phase 4. Although the exposure of this drain fill in 2017 (FXO17 [28]) had suggested that it was a silt, only in its upper horizons with demolition material in it (Dearne 2017c, 19), the present work fully cleared a larger section of it (and partly excavated an area of it where there had been Phase 3 modification) which allowed the full study of complete sections through the fill. Only moderately compacted, the fill was, as in 2017, a dark brown (10 YR 3/3) clayey silt, here with moderately frequent brick fragments (to 0.10 m, some retaining mortar) and peg tile fragments (to 0.10 m), some oyster shells and roundwood charcoal as well as rather more frequent and larger rounded pebbles (to 0.04 m) than in 2017. The presence of the brick fragments throughout the deposit to the base of the drain suggested that it was more likely a deposit connected to site demolition, or at least a mixture of drain silt and backfill, than just a silt relating to use of the drain. This fill also had an upper surface level with the top of the drain which might not be expected if it had simply been a silt and processing of bulk samples of it found that it contained 67% by weight of pebbles and 2.9% by weight of cbm fragments. The bulk sample processing also recovered a small amount of animal bone including from pig, rabbit, rat and mouse as well as egg shell fragments and four *teleostid* fish bones including one from the Common Carp (*Cyprinus carpio*), but it now seems most likely that the fill was at least largely deposited as part of the demolition process as probably emphasised by the presence of a fragment of a ragstone fireplace in it (see Appendix 3).
