ENFIELD ARCHAEOLOGICAL SOCIETY ARCHIVE REPORT

EXCAVATIONS AT ELSYNG PALACE, FORTY HALL, ENFIELD, MAY - JULY 2018

(SITE CODE FXQ18)

by
MARTIN J. DEARNE

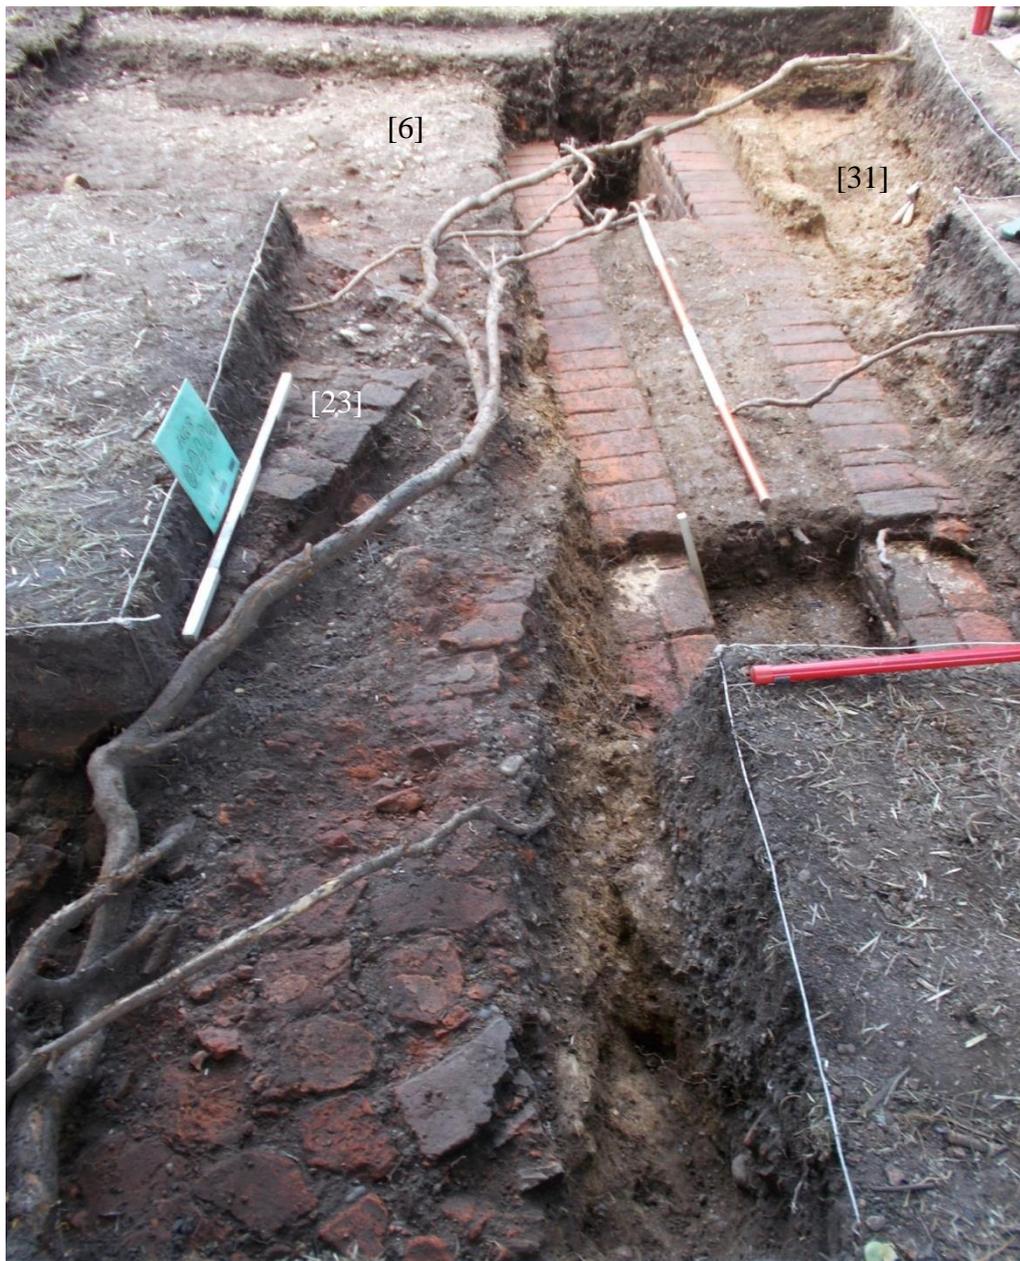
Pl. 4: Cut [31] (Top Right), Drain [15] with its Phase 3 Modification in the Foreground, to Left Floor [6] and (Foreground) Corner of Wall [5]/[23] Flanked by Surface [24], Looking West (Photo MJD)

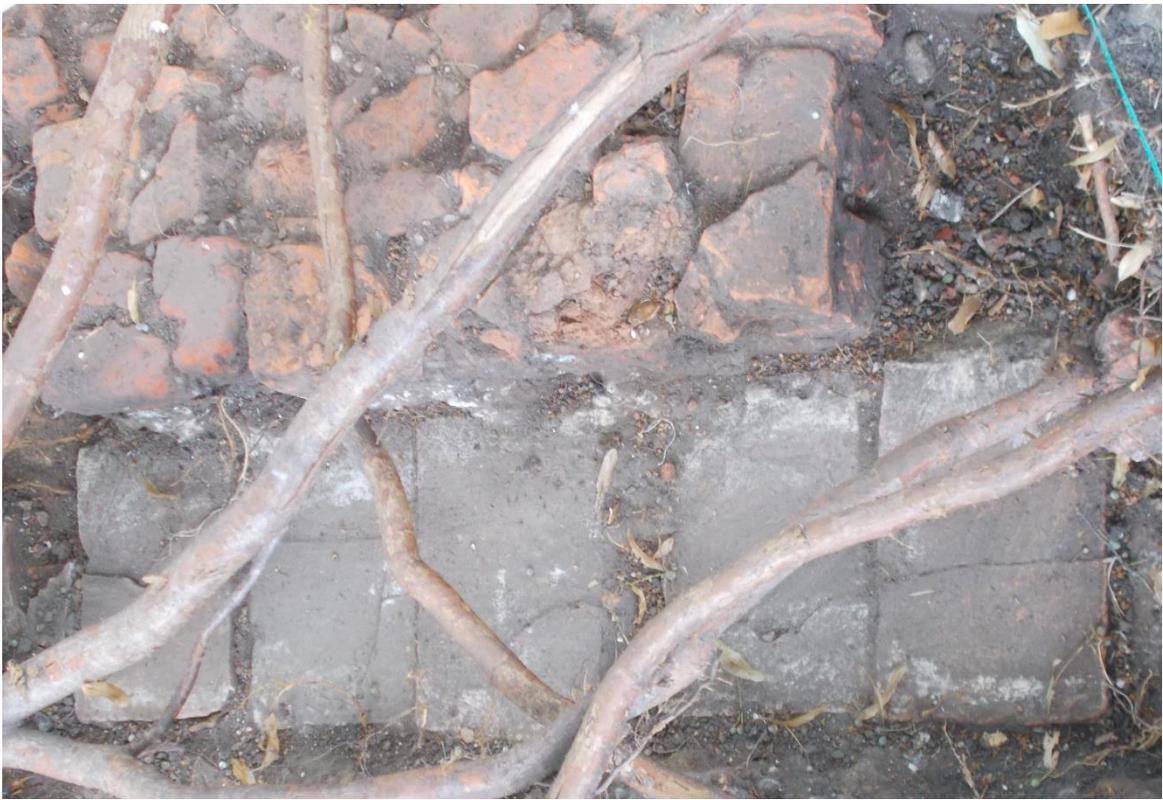
Pl. 5: Detail of Wall [46] Showing Whitewash/Mortar Outlining the Base Beam with Phase 3c Floor [55] to the East (Top) (Photo MJD)

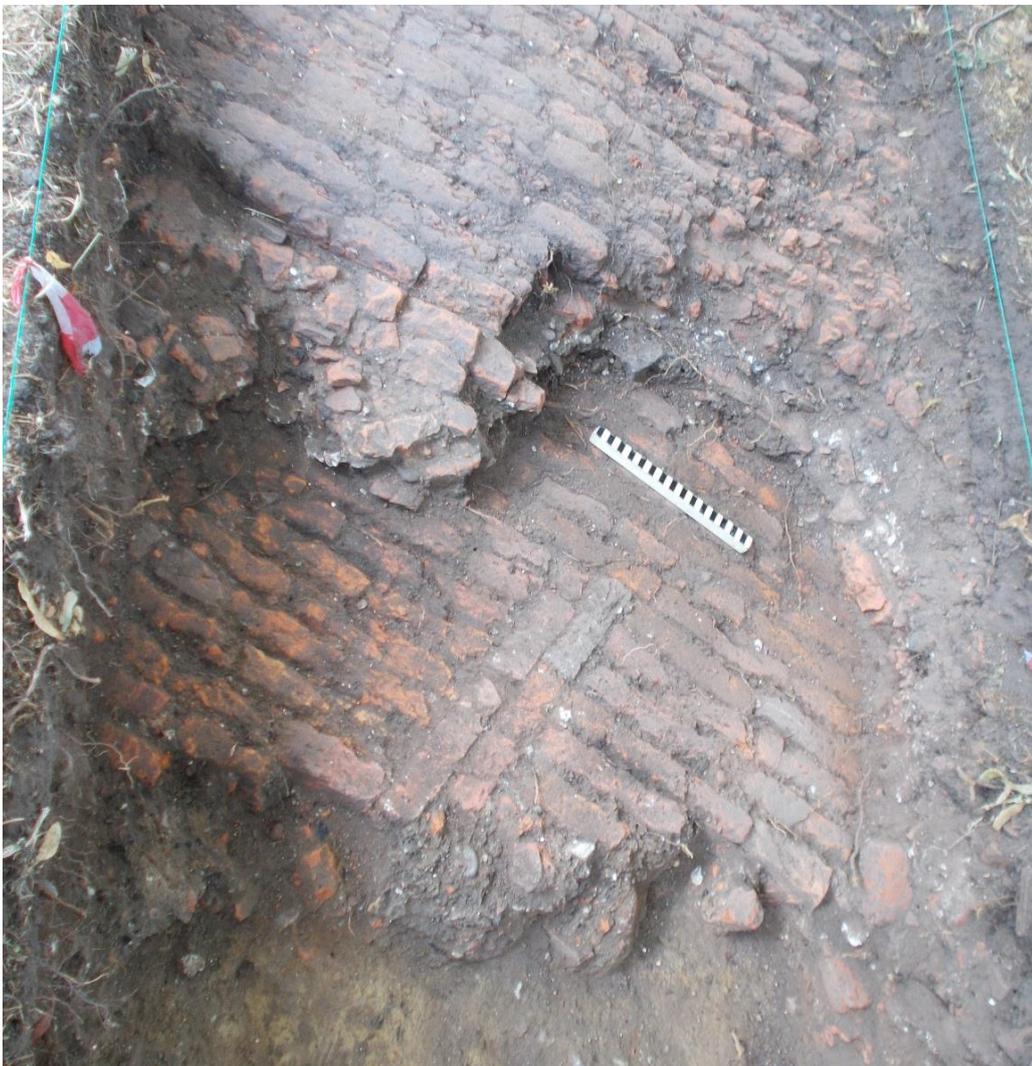
Pl. 6: Phase 2 Floor [40] Exposed Below Phase 3b Floor [32] by Cut [41], Looking West (Photo MJD)

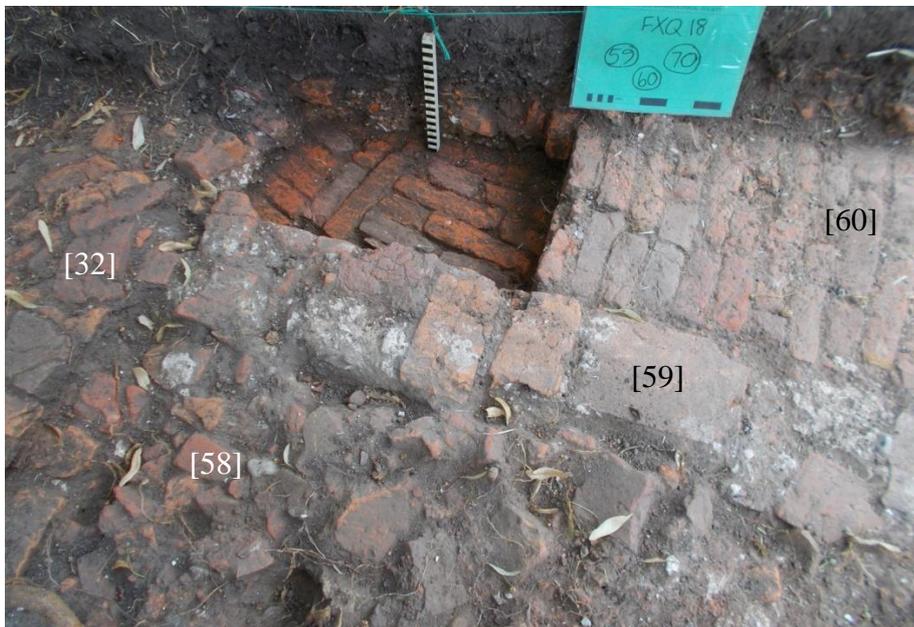
Pl. 7: Phase 2 Floor [70] Exposed by the ?Removal of a Later ?Wall at the North End of Phase 3b Floor [60] Beside Wall [59], Looking East (Photo MJD)

- Unremoved later floors prevent certainty, but Room 4 seems to have been divided from Room 6 by only a brick threshold (part of [32]) in Phase 3b (Pl. 7) and so may always have been open on the north. Excavation within this room in 2018 was limited and only served to confirm earlier findings that its very worn rammed pebble and chalk lump floor [57] (= FXO17 [12]) – only a remnant of which survived beside the threshold – lay on a rubble and brick dust bedding [58] (= FXO17 [13]) which was not fully removed in this instance (Pl. 7). This room in fact now seems to have been (or at some point to have been partitioned into) two irregularly shaped rooms, the northern, Room 4, from 3.20 to around 3.90 m east west and either 4.00 – 4.60 m or 4.60 – 5.35 m north south depending on which of two walls ([81] and [82]) formed the presumed division between it and Room 8 to its south. Neither wall can be certainly phased and the presence of a large and partly collapsed tree made excavation in the south of Room 4 and in Room 8 impossible. However, that the east wall of Room 4 ([59] = FXO17 [2]) is known from work in 2017 to have been a Phase 3 (indeed, it is now evident Phase 3b) rebuild makes it most likely that the room was divided sometime later in the building's history so walls [81] and [82] are discussed under Phase 3.

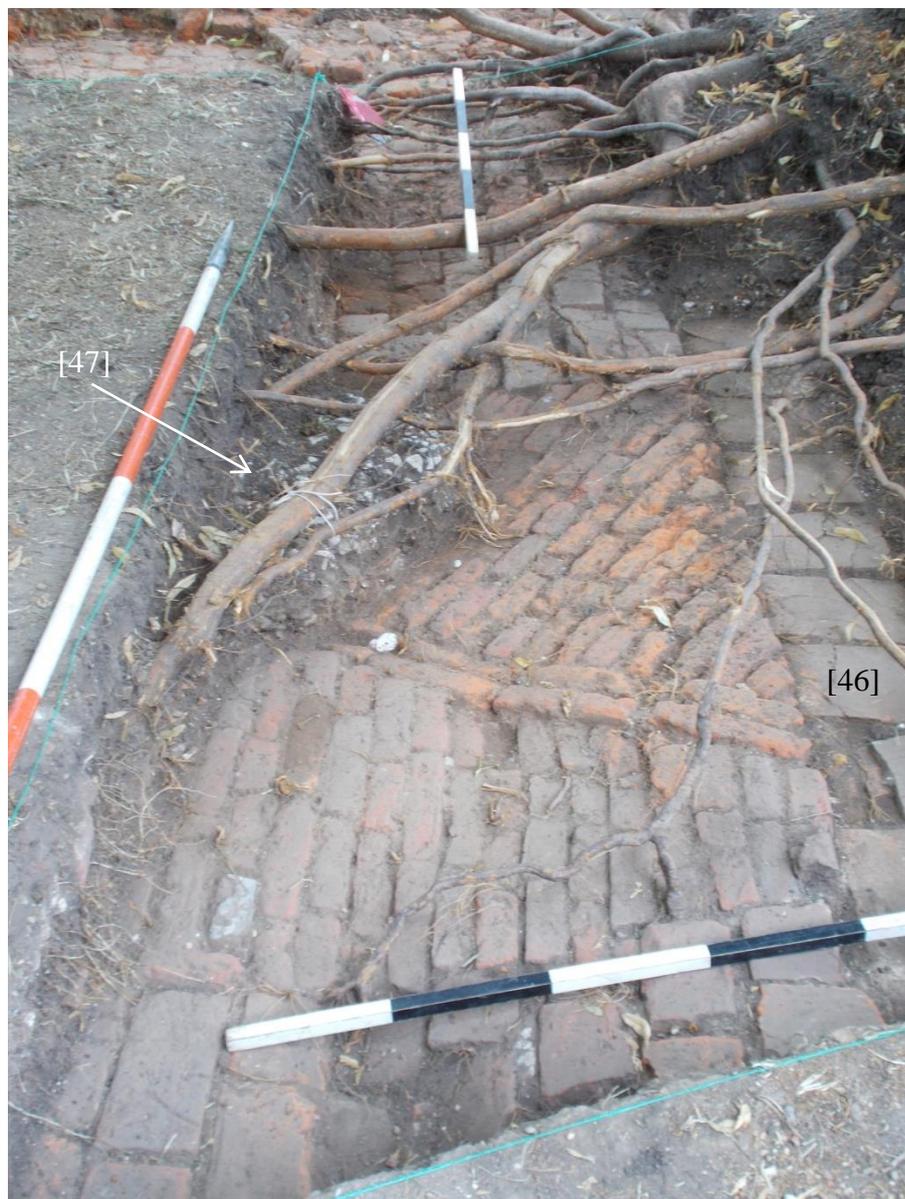
Pl. 8: Phase 3a Floor [56] Beside Wall [46] with a Block of Phase 3d Floor [47] Left *in situ*, Looking South (Photo MJD)

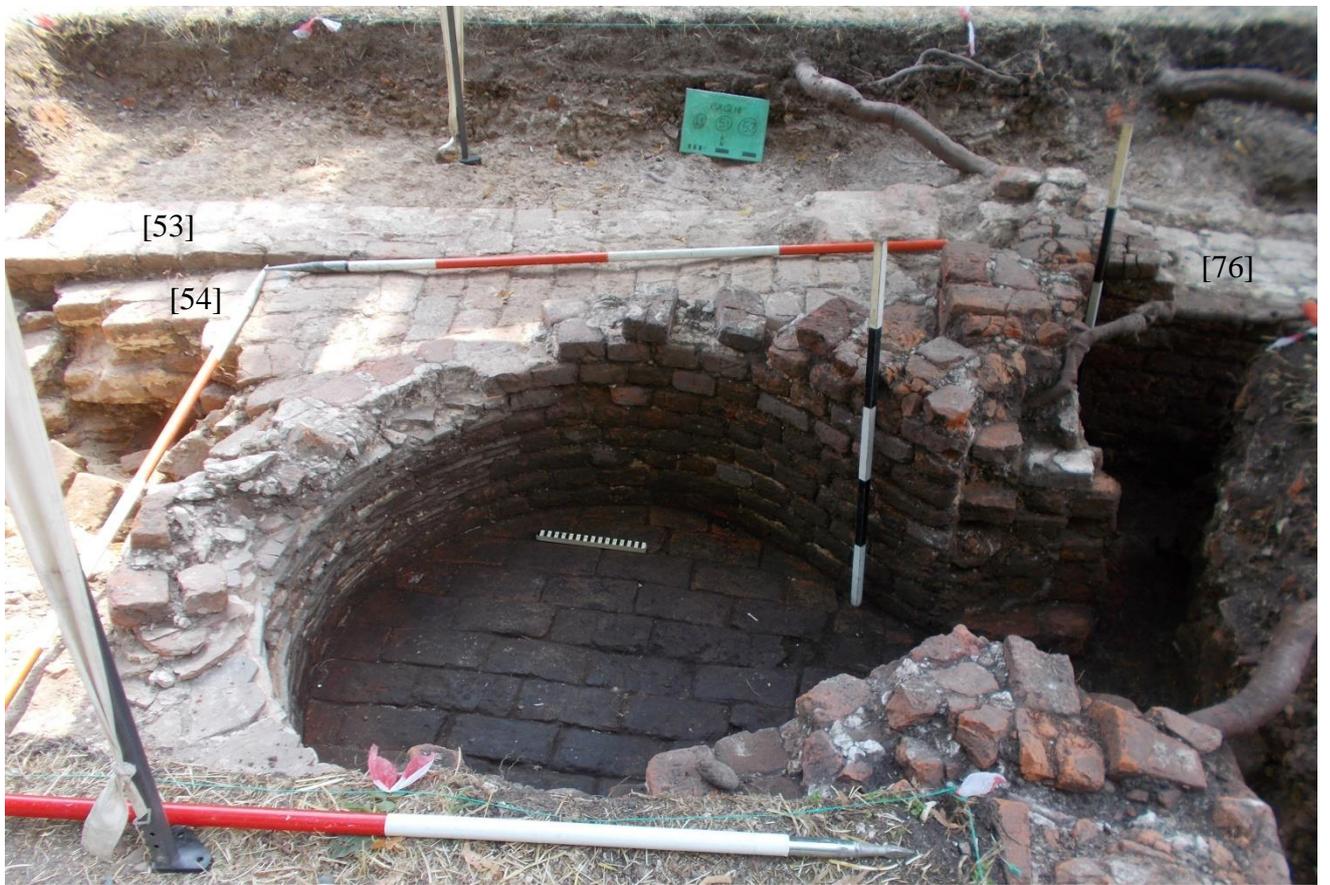
Pl. 9: Furnace [52] with Buttressing Wall [54] Between it and the Facade Wall [53], Looking South (Photo MJD)

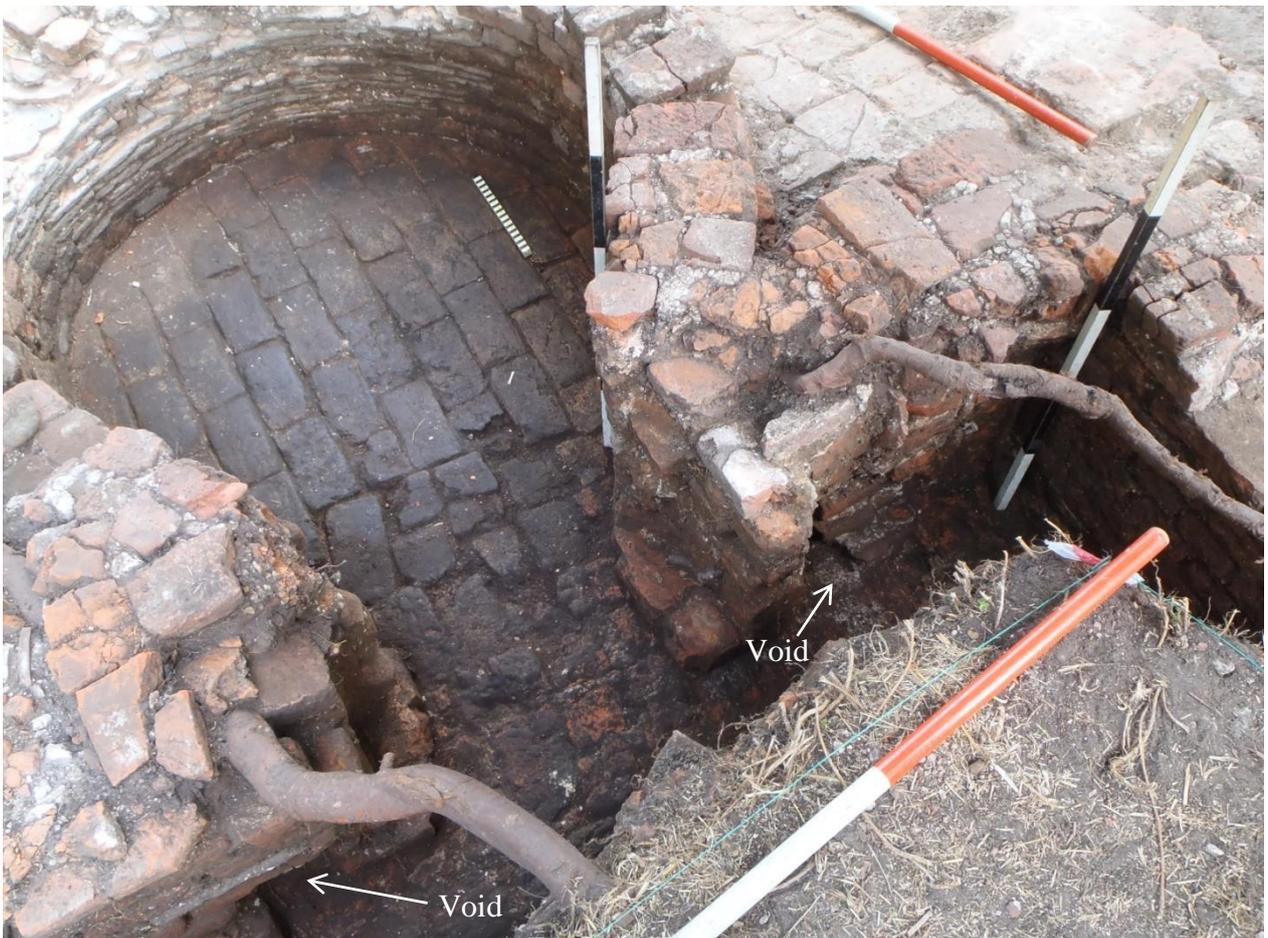
Pl. 10: Furnace [52] Looking East, Showing Damaged and Root Disrupted Cheeks [43]/[83] (to Left) and [51]/[84] (Photo John Pinchbeck)

in 2017. Thus, parts of the damage to the cheeks of the furnace was clearly being worsened by the ingress of major tree roots (Pls 10 and 13), much of the western part of Room 5 was if not disrupted then in danger of being disrupted by major tree roots (Pl. 11) and at one point wall [62] had been cracked apart and moved by tree root heave. Again, even just deturfing showed that the westernmost exposure of wall [76] has probably already been irretrievably disrupted. As emphasised by the findings in Trench 8 (and FXO17 Trench 1) especially, repeated tree throw/planting has already rendered some areas archaeologically useless and no new tree planting or sapling seeding should be allowed in this area under any circumstances. Indeed, it is to be greatly regretted that tree planting was allowed in ENC05 Pit 23 (tree 0833) some years ago and the immature tree now occupying this position may well in due course pose a threat to the survival of features such as the Room 5 furnace.

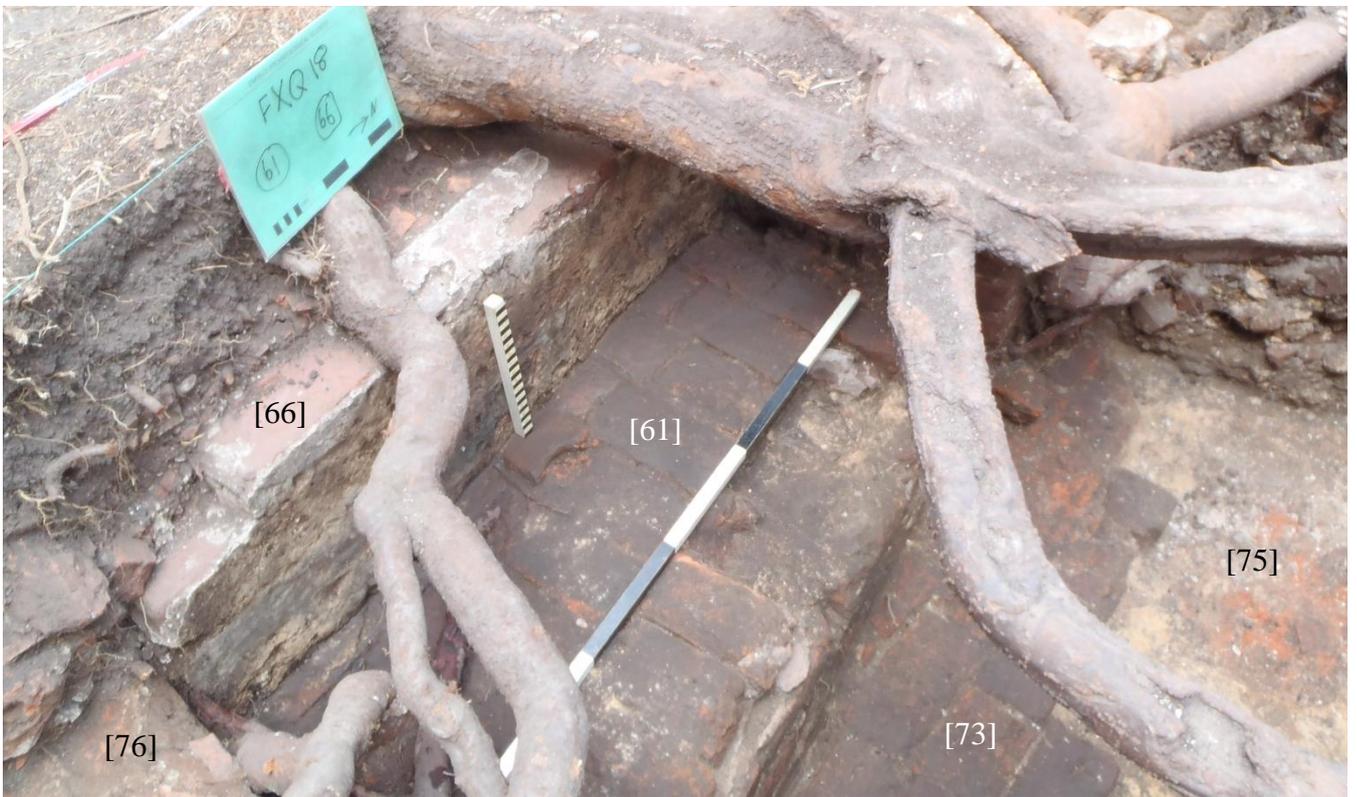
Pl. 11: The Room 5 'Cupboard', Looking North (Photo John Pinchbeck)

- At the north end of the ‘cupboard’ was a c. 0.90 x 0.58 m block of brickwork, [42], which survived to 0.43 m high, but the base of the 0.09 m thick mortared rubble foundations for it lay 0.16 m above the level of floor [73] (at least in the small east face exposure available). Above the foundations it survived to five courses of probably rather irregular English bond brickwork bonded with a hard, very pale brown (10 YR 8/4) mortar, though the top surviving surface showed the use of the very hard white mortar used for the ‘cupboard’. As well as forming the north side of this ‘cupboard’, the construction had an integral 0.47 m wide north west running arm forming wall [81] which was built on/into the natural, perhaps in a construction trench backfilled with [87], a redeposited brickearth with rare brick fragments seen only in the north section of the trench. [81] survived to four courses of whole and part bricks, perhaps laid as stretcher bonded faces to a rubble core and probably using the 10 YR 8/4 mortar.

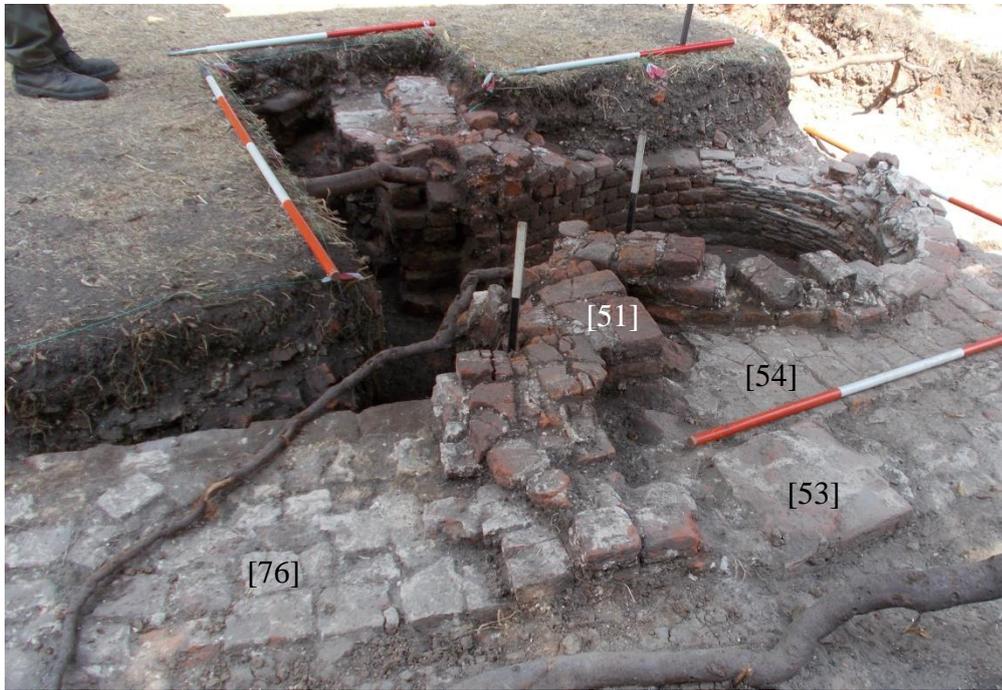
Pl. 13: The Junction of Walls [76] and [53]/[54] and Furnace Cheek [51], Looking North (Photo MJD)

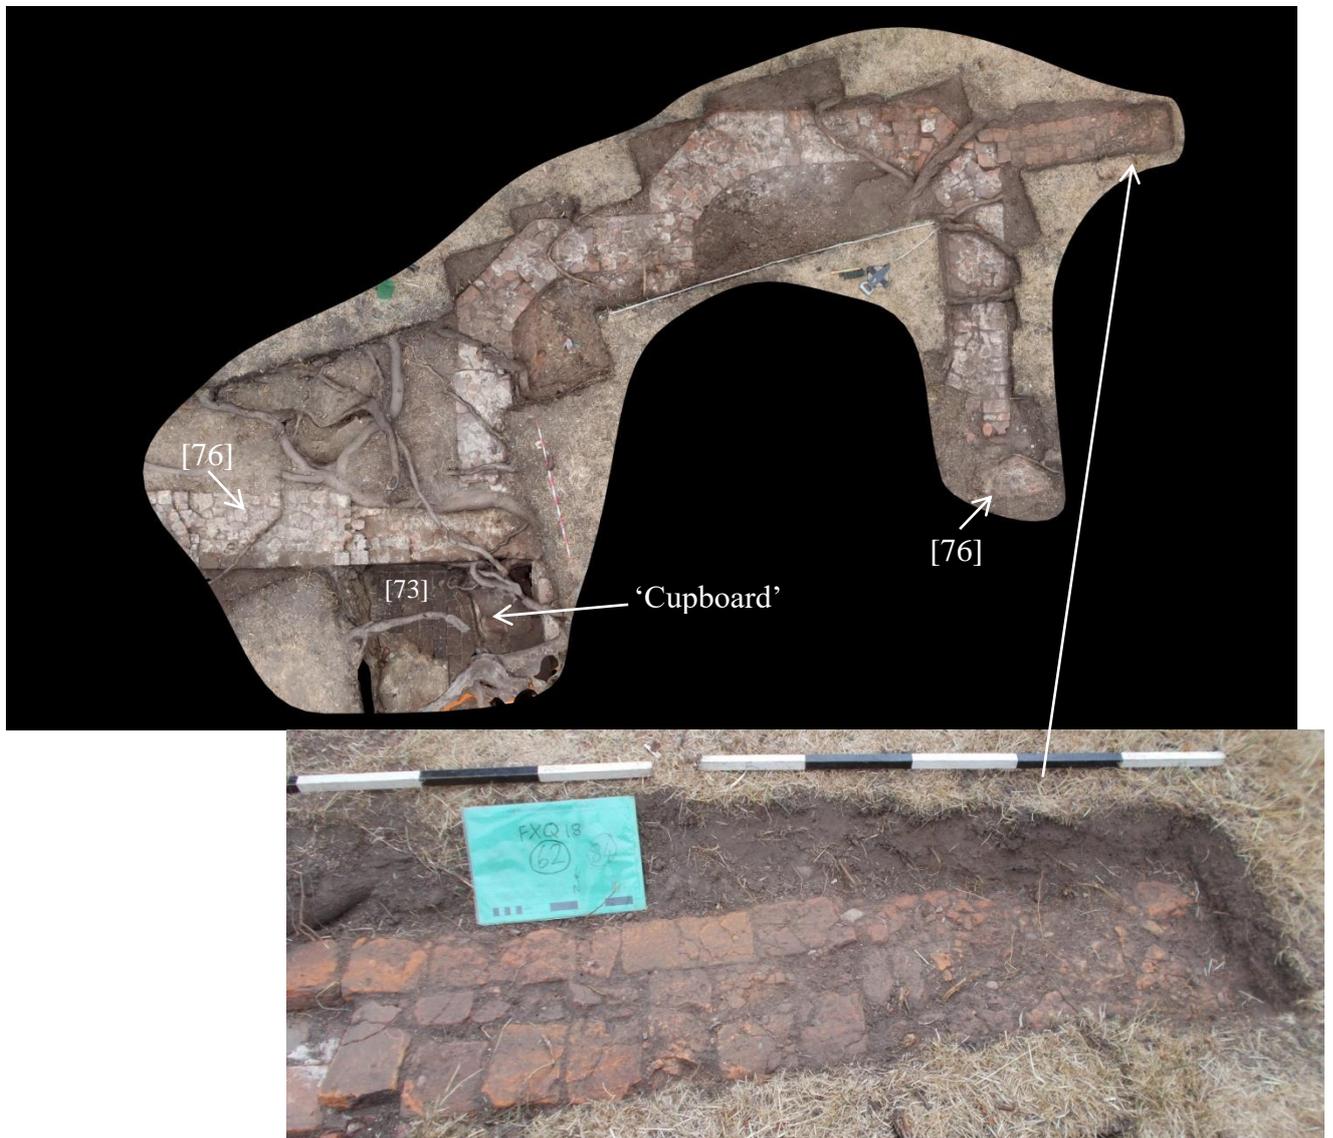
Pl. 14: Multiangular Tower [62]/[84] (Vertical Photo Mosaic by John Pinchbeck) with Detail of Damage to Wall [84] Looking South (Photo MJD)
